TECHNICAL REPORT

MOUNT HENRY SPIT RESTORATION PLAN

SEPTEMBER 2014

FOR
CITY OF SOUTH PERTH

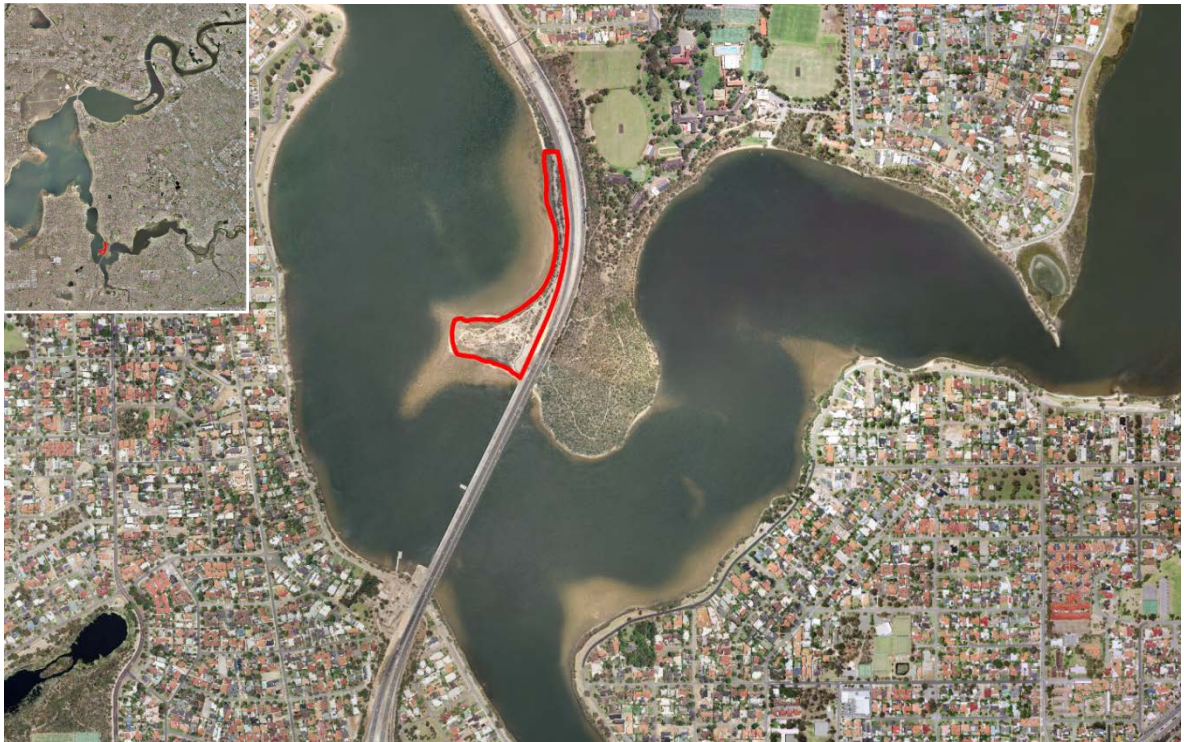
Figure 1 Site location within the Perth Metropolitan Area (Imagery: Landgate, 2006)

This restoration plan covers the area of approximately 4.03 ha which includes 900 linear metres (Lm) of foreshore and encompasses the dryland area up to the Kwinana Freeway road reserve (Figure 1).

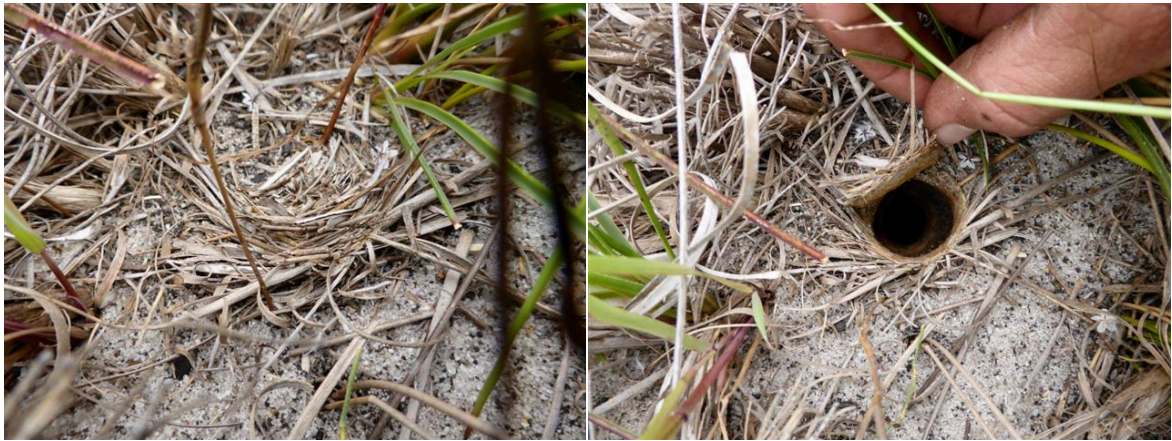
Figure 2 Trapdoor spider nest at Mount Henry Spit October 2013 (Source: City of South Perth)

An incidental observation by the City's Natural Areas Maintenance team has recorded a trapdoor spider nest on site in October 2013. Whilst the spider was not located, the nest was in good condition indicating that it had likely been recently maintained by the spider. Several photographs (see Figure 2) were sent to the WA Museum for confirmation and the first indications are that the nest might be that of the *Idiosoma hirsutum* a rare species which is known to occur at Salter Point and few other locations in the Perth Metropolitan area.

Although unconfirmed, it is important that prior to any restoration works detailed inspections are made to ensure no disturbance to trapdoor spider nests or other native fauna occur. If found the locations of the nests should be clearly marked to avoid their disturbance. The City and the Contractor should consult with the expert fauna specialists to identify the species and seek the best strategy for its protection. For this reason it is prudent to complete detailed site inspections well in advance of restoration works (i.e. at a minimum of 2-3 weeks prior to start of works).

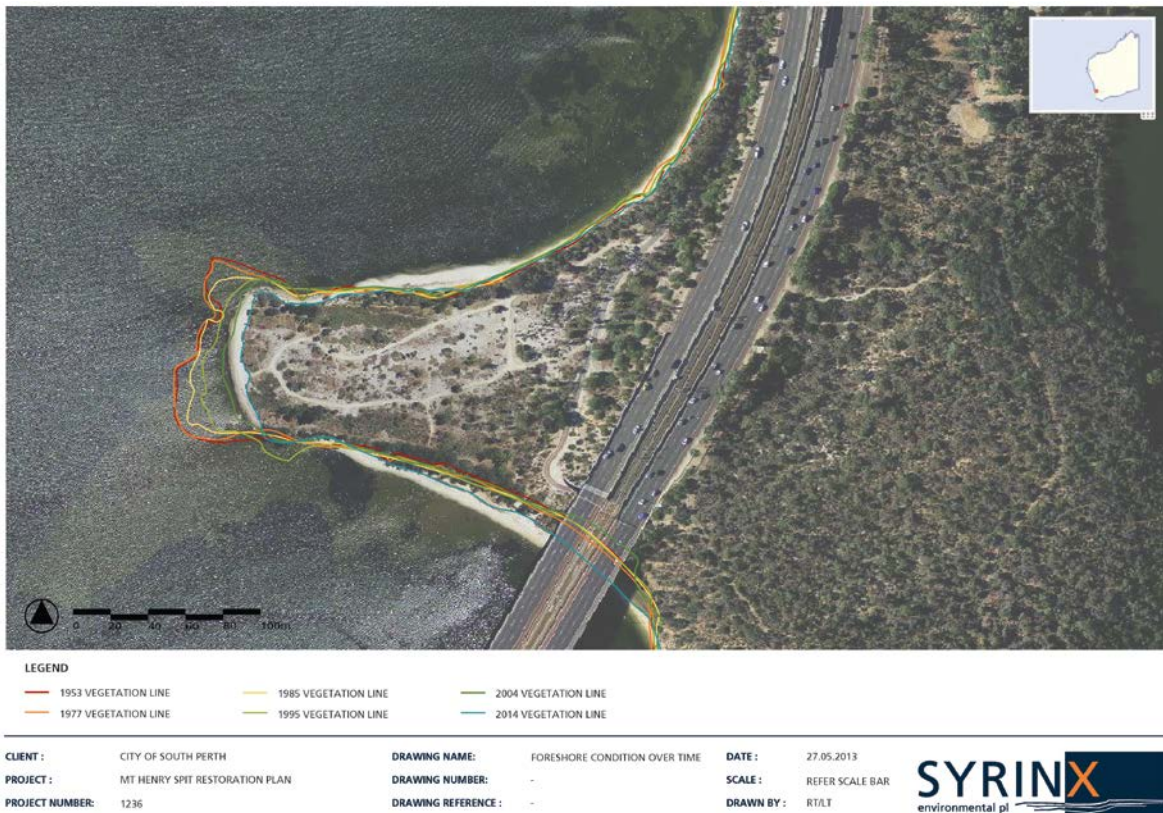
Figure 3 Traces of foreshore erosion from 1953 – 2014 (Source: Historical photographs from Landgate, 2013)

Note: traces of the vegetated areas were taken as opposed to the beach extent to avoid errors due to different water levels.

The examination of the historical aerial photographs available through Landgate (2013) has indicated that, since 1953 the erosion of the Spit has been relatively rapid at an average rate of approximately 800 mm per year (Figure 3). Ecoscape (2004) stipulates that just within one decade (1988 – 1997) the Spit had retreated about 5 - 10 metres. The causes of the erosion were listed as likely due to:

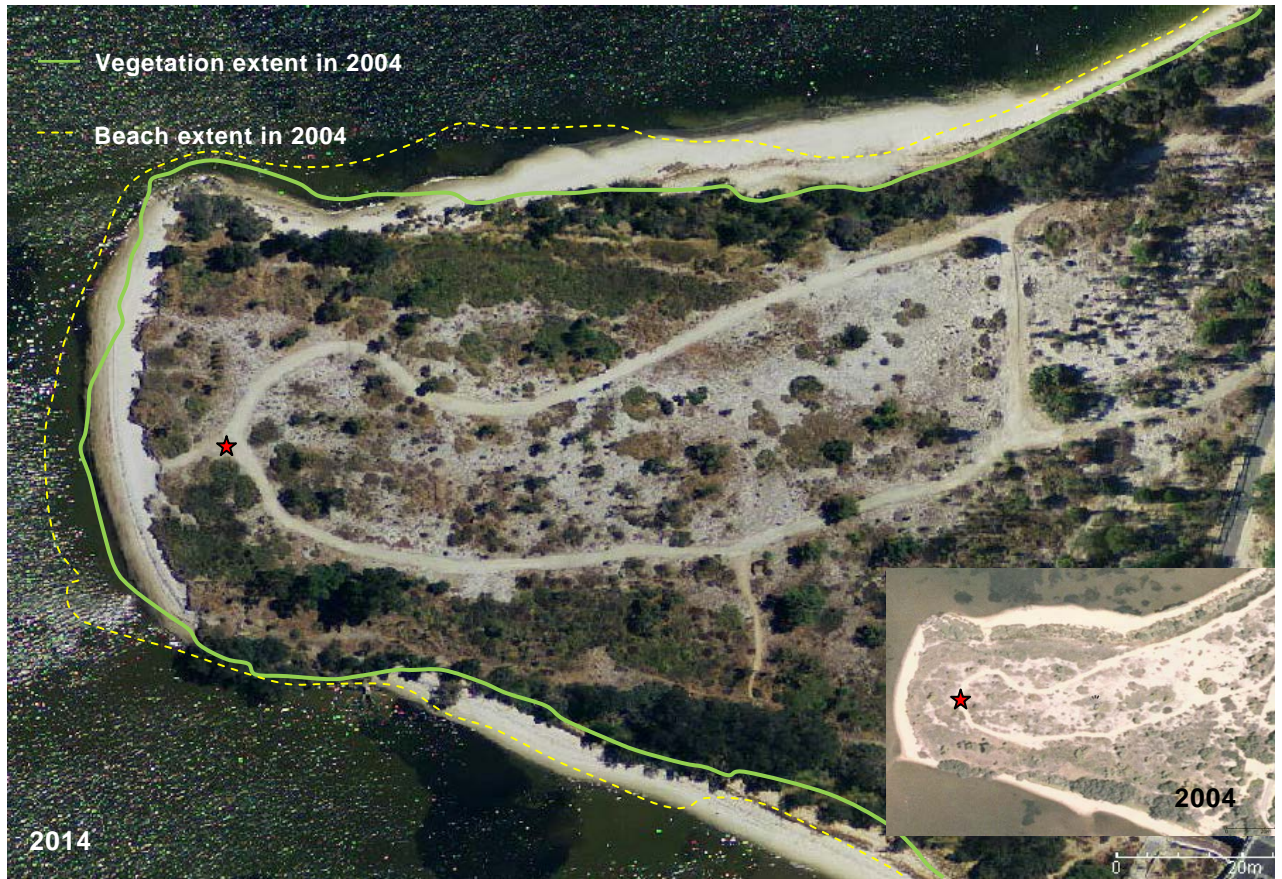
Figure 4 Rate of erosion at the spit end between January 2004 and January 2014
 (Image source: Landgate Map Viewer:
<https://www.landgate.wa.gov.au/bmvf/app/mapviewer/>)

★Red star is used as a reference marker to show the extent of erosion.

Approximately 13 – 15 m of shore are lost per decade since bridge construction. The erosion and sand accumulation / movement at the spit in the last decade (between 2004 and 2014) is shown in Figure 4.

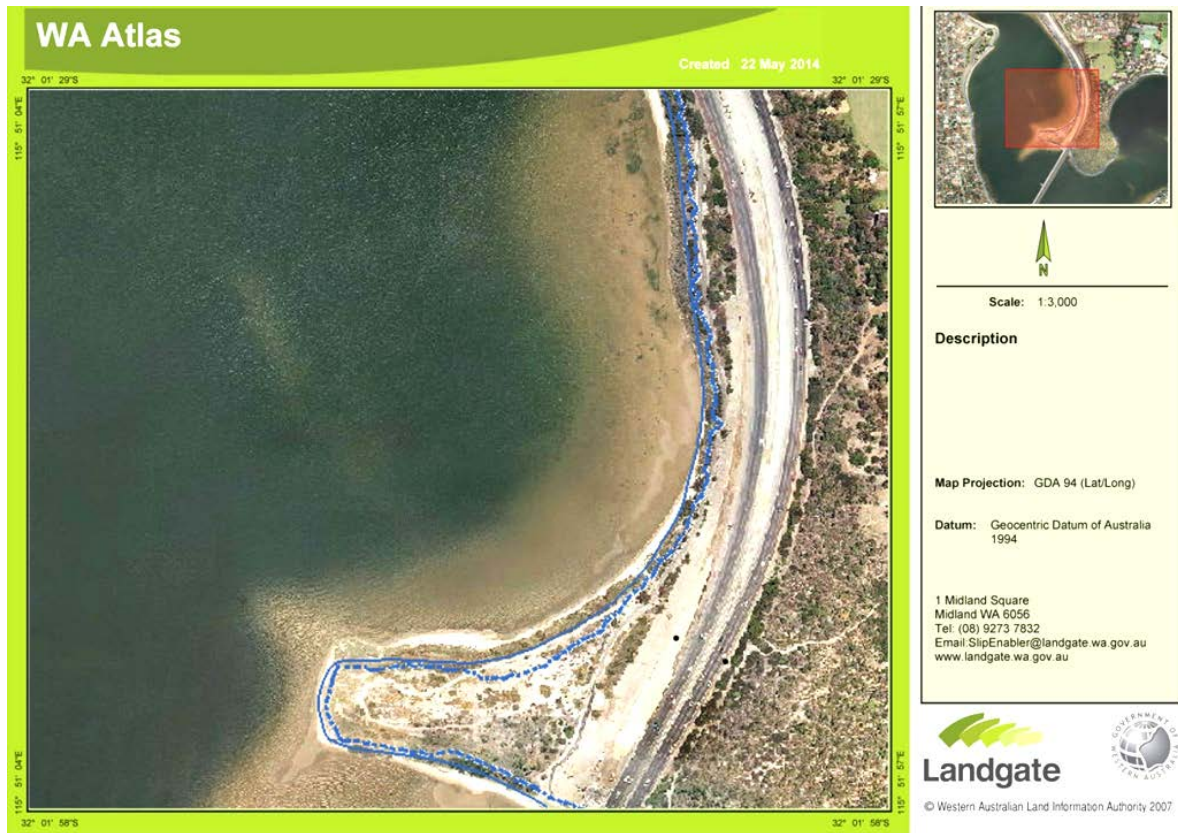
Figure 5 100 year ARI Floodway and Flood Fringe Line (Source: Landgate , 2014 with dataset by DoW (2013a))

indicates that large areas of foreshore (~30% of the site) are subject to flooding under current 100 year ARI (DoW, 2013a).

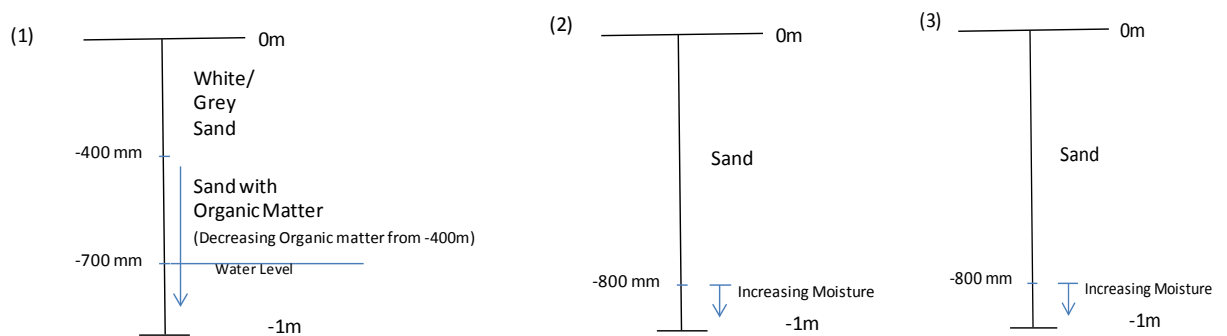
Soil profile 1 was composed entirely of sand with some organic matter noted at 400 mm below the surface (Figure 8). Below 400 mm there was a decreasing percentage of organic matter in the soil. Groundwater was noted at 700 mm below the surface. Soil profiles for sites 2 and 3 had a similar composition with sand dominating the soil profile and an increase in soil moisture at 800 mm below the surface level (Figure 8).

Figure 8 Soil profiles taken at Mount Henry Spit outlining soil composition and moisture levels

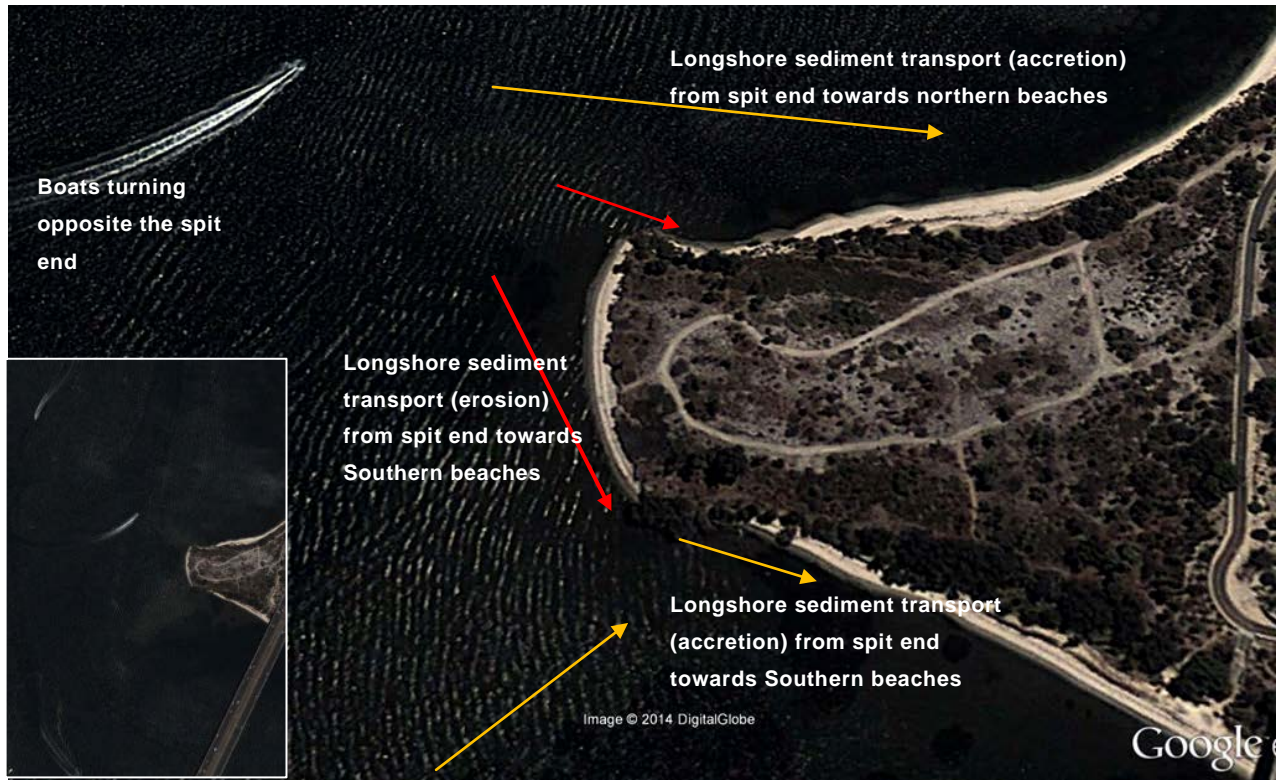
Figure 9 Wave pattern generated by boat wake indicating erosion of the spit end and deposition of sediments along the spit flanks (Imagery: Google Earth, 2014)

The storm surges are likely to greatly accelerate erosion on site because the shoreline has already been destabilised via undercuts (formed most likely as a result of boat turning in close proximity to the spit point and wind waves) and has no protective vegetation layer.

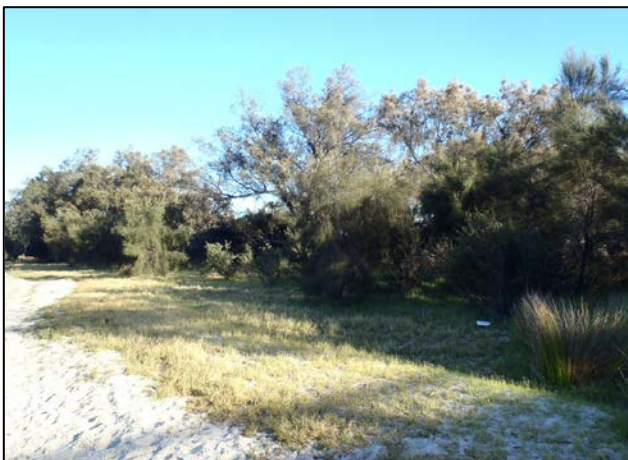
Community 1 Low Open Forest of *Casuarina obesa* and *Melaleuca cuticularis* with Scattered shrubs of *Rhagodia baccata* over Sedgeland of *Juncus kraussii*, *Schoenus subfascicularis* and *Gahnia trifida* over Open Grassland of *Sporobolus virginicus* and **Cynodon dactylon* with Scattered Herbs of *Suaeda australis*, *Sarcocornia quinqueflora* and **Chenopodium album*

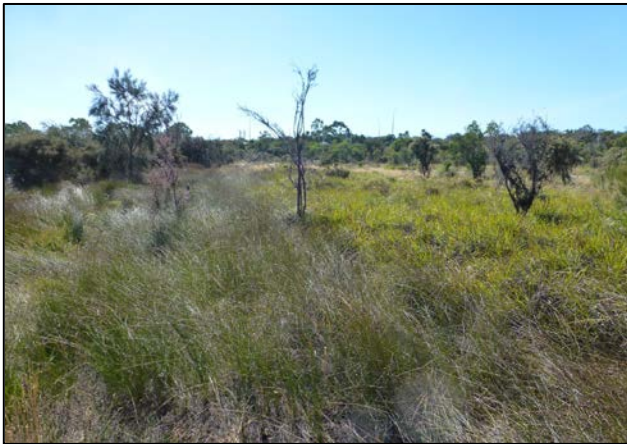
Community 2 Low Open Woodland of *Allocasuarina fraseriana* and *Nuytsia floribunda* over Open Shrubland of *Jacksonia furcellata* and *Xanthorrhoea preissii* over Scattered Low Shrubs of *Hibbertia hypericoides*, *Hypocalymma angustifolium* and *Acacia stenoptera* over Closed Sedgeland of *Hypolaena exsulca* and *Schoenus subfascicularis* with Very Open Herbland of *Phlebocarya ciliata* and *Dasypogon bromeliifolius*

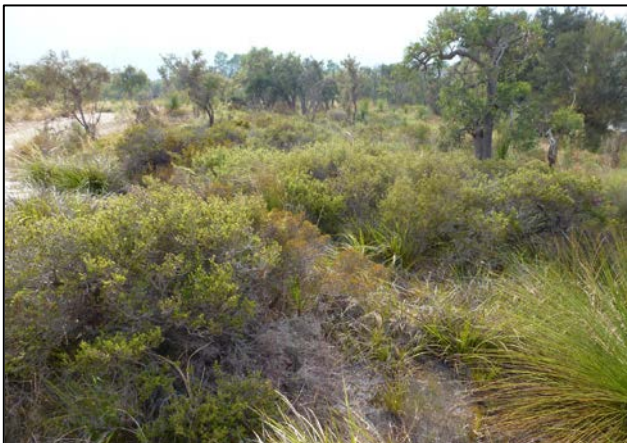
Community 3 Scattered Trees of *Nuytsia floribunda* and *Corymbia calophylla* over Shrubland of *Eremaea pauciflora*, *Hibbertia hypericoides*, *Lechenaultia floribunda* and *Xanthorrhoea preissii* over Very Open Herbland of *Phlebocarya ciliata* and *Patersonia occidentalis*

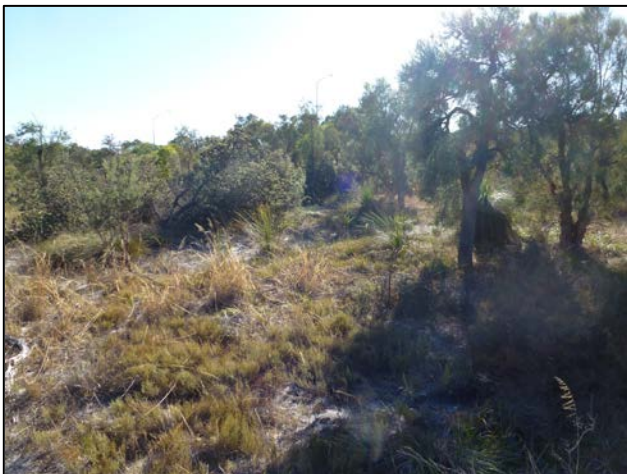
Community 4 Low Open Woodland of *Nuytsia floribunda* and *Allocasuarina fraseriana* over Tall Shrubland of *Jacksonia furcellata* and *Adenanthos cygnorum* over Low Open Shrubland of *Lechenaultia floribunda* and *Allocasuarina humilis* over Very Open Herbland of *Dasypogon bromeliifolius*, *Phlebocarya ciliata* and *Corynotheca micrantha* over Very Open Sedgeland of *Lyginia barbata* and *Alexgeorgea nitens* with Very Open grassland of **Ehrharta calycina*

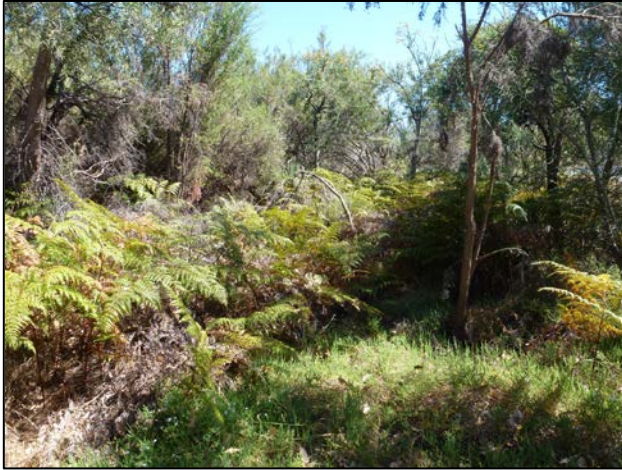
Community 5 Low Open Woodland of *Nuytsia floribunda* and *Corymbia calophylla* over Tall Shrubland of *Kunzea glabrescens* and *Jacksonia furcellata* over Low Open Shrubland of *Lechenaultia floribunda*, *Acacia stenoptera* and *Xanthorrhoea preissii* over Sedgeland of *Schoenus subfascicularis* over Very Open Herbland of *Phlebocarya ciliata* and *Corynotheca micrantha* with *Pteridium esculentum*

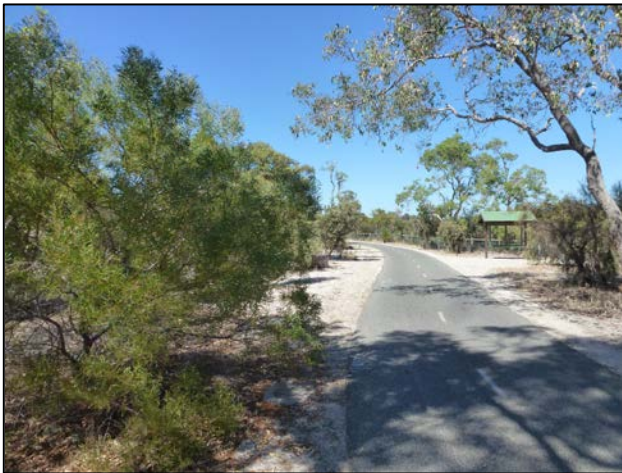
Community 6 Mixed Exotics: Tall Shrubland of *Acacia saligna*, *Chamelaucium uncinatum* and *Acacia cyclops* over Open Shrubland of *Kunzea glabrescens*, *Melaleuca huegelii* and *Hakea prostrata* over Very Open Grassland of **Ehrharta calycina* and **Avena barbata*

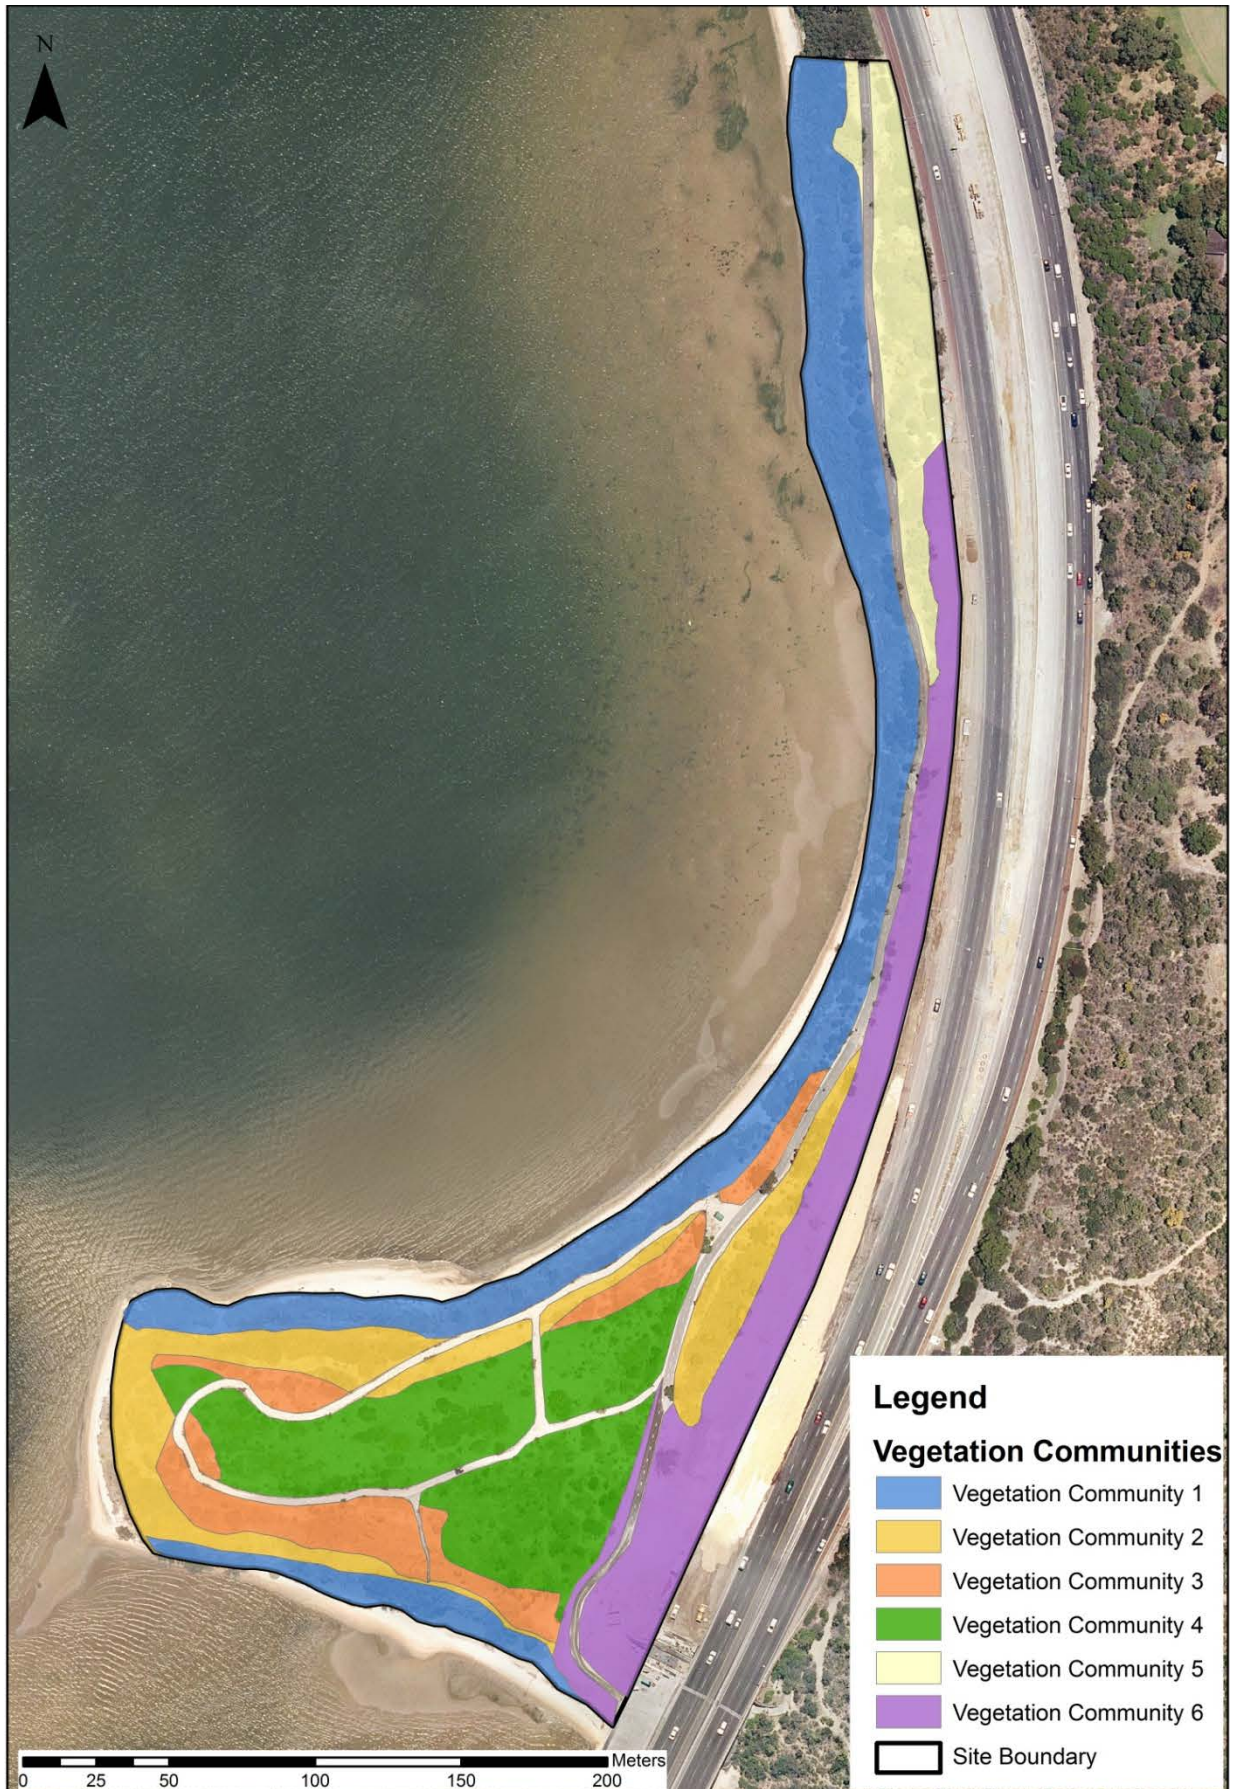
Figure 10 Vegetation communities of the Mount Henry Spit

A total of six vegetation communities were described for the Site based on the species composition and abundance. The photographs of each community together with the community description based on the dominant flora are presented below. The map showing the distribution of each community is presented in Figure 10.

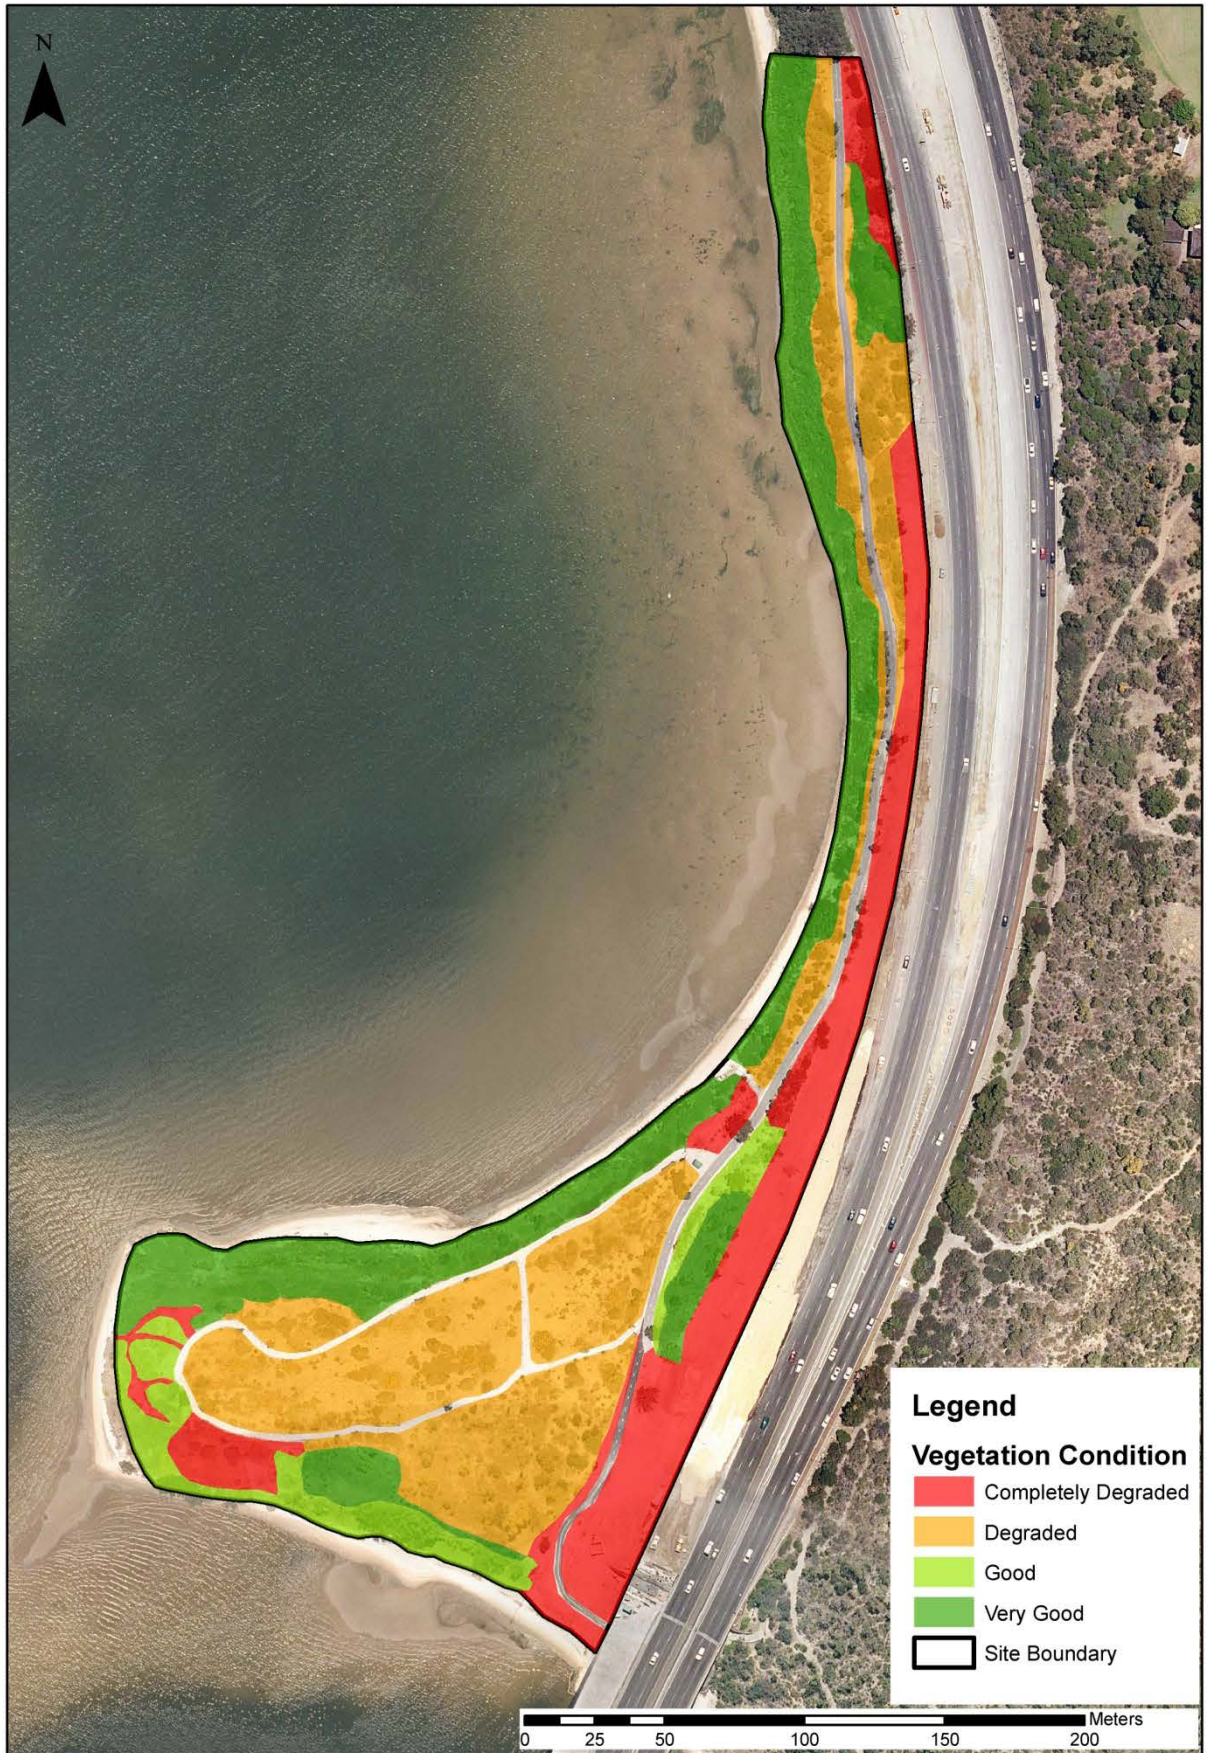
Figure 12 Vegetation condition of the Mount Henry Spit

The condition of vegetation on site ranged from Completely Degraded to Very Good, based on the condition scale adapted from Keighery (1994) (see Table 2). However, the majority of the Site (64.5%) is considered to be Degraded to Completely Degraded, largely because of clearing and trampling of native vegetation and the presence of exotic flora species such as grasses and planted non-native species (e.g. flora such as that along the freeway embankment) (see Figure 12).

Species composition of vegetation communities found in areas that were considered of Good (7.5%) and Very Good (28%) condition were used to form a list of species required to restore the degraded areas, to a pre-disturbance condition.

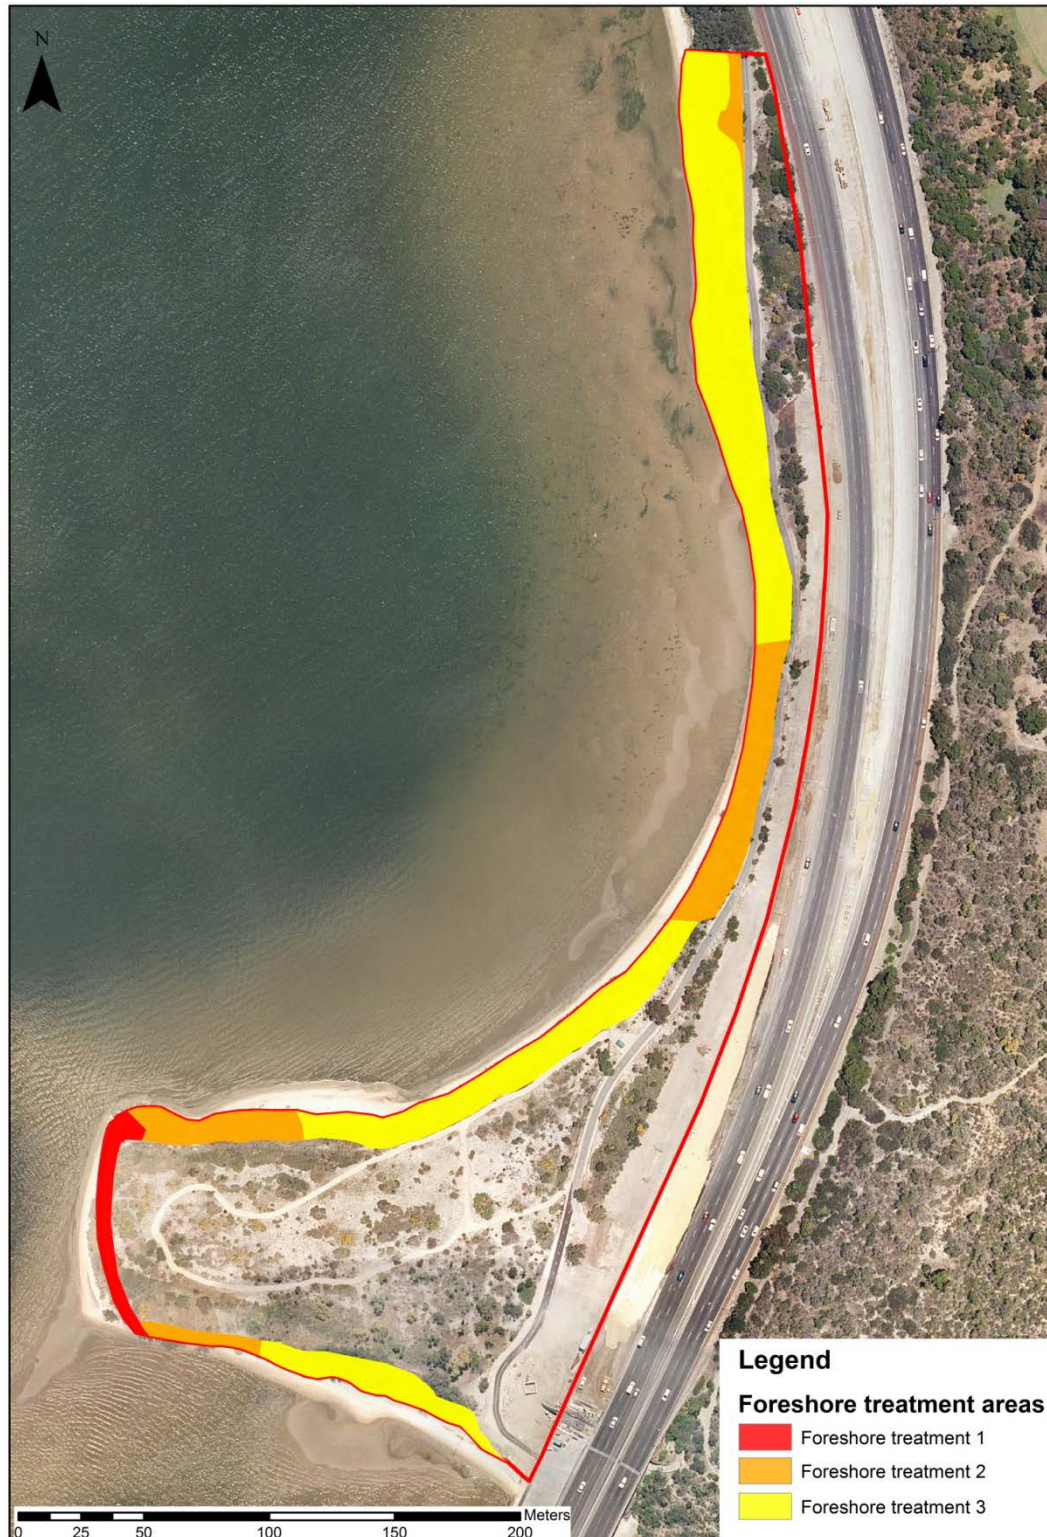
Figure 13 Treatment of foreshore areas for restoration

Based on the results obtained during the field assessment (Appendix 1), the foreshore of the Mount Henry Spit has been categorised into 3 distinct foreshore treatments based on the condition of the foreshore and the level of disturbance that has affected these areas (Figure 13).

The area classified as Foreshore treatment 1 (Figure 13) has been identified as having the highest degree of erosion, and as such, has been given the highest priority for restoration. Due to the extent of erosion, this area will require most input in terms of erosion mitigation works. The primary objective will be to reintroduce fringing riparian vegetation, currently completely absent from this section of the foreshore. The vegetation will act as a buffer to wave and tidal action and will significantly reduce the current rate of erosion in this area and thus protect the existing vegetation communities.

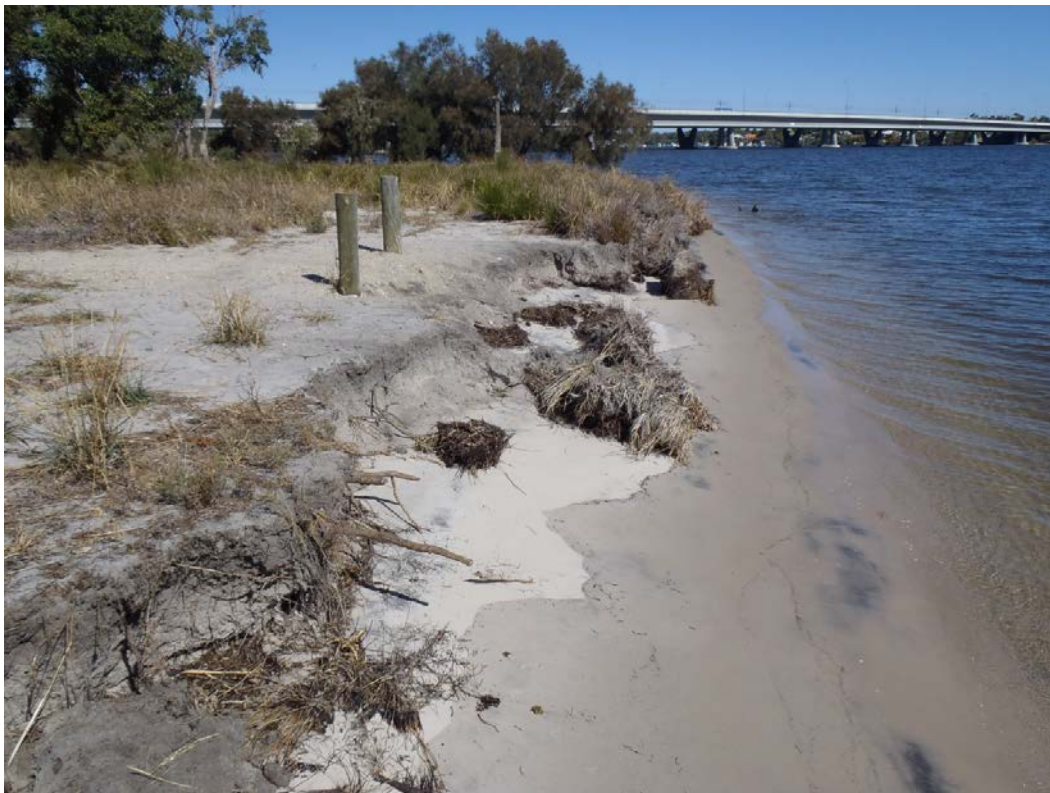
Figure 14 Foreshore treatment 1 area at the westernmost end of the Mount Henry Spit

Bioengineering works will be comprised of the construction of a brushwall along the intertidal area of foreshore. The structure will be constructed at a height that substantially exceeds maximum water levels and extend approximately 2 to 3 m from the existing bank to allow sufficient width for the establishment of foreshore vegetation. The vegetation planted in this area should be comprised of species native to the intertidal zone of the river, with an

Limestone spalls along the toe of the brushwall on the river side need to be installed to provide protection to the structure and to ensure the erosion fabric installed underneath the brushwall remains in place. This small rock toe only needs to extend approximately 1 m from the base of the brushwall.

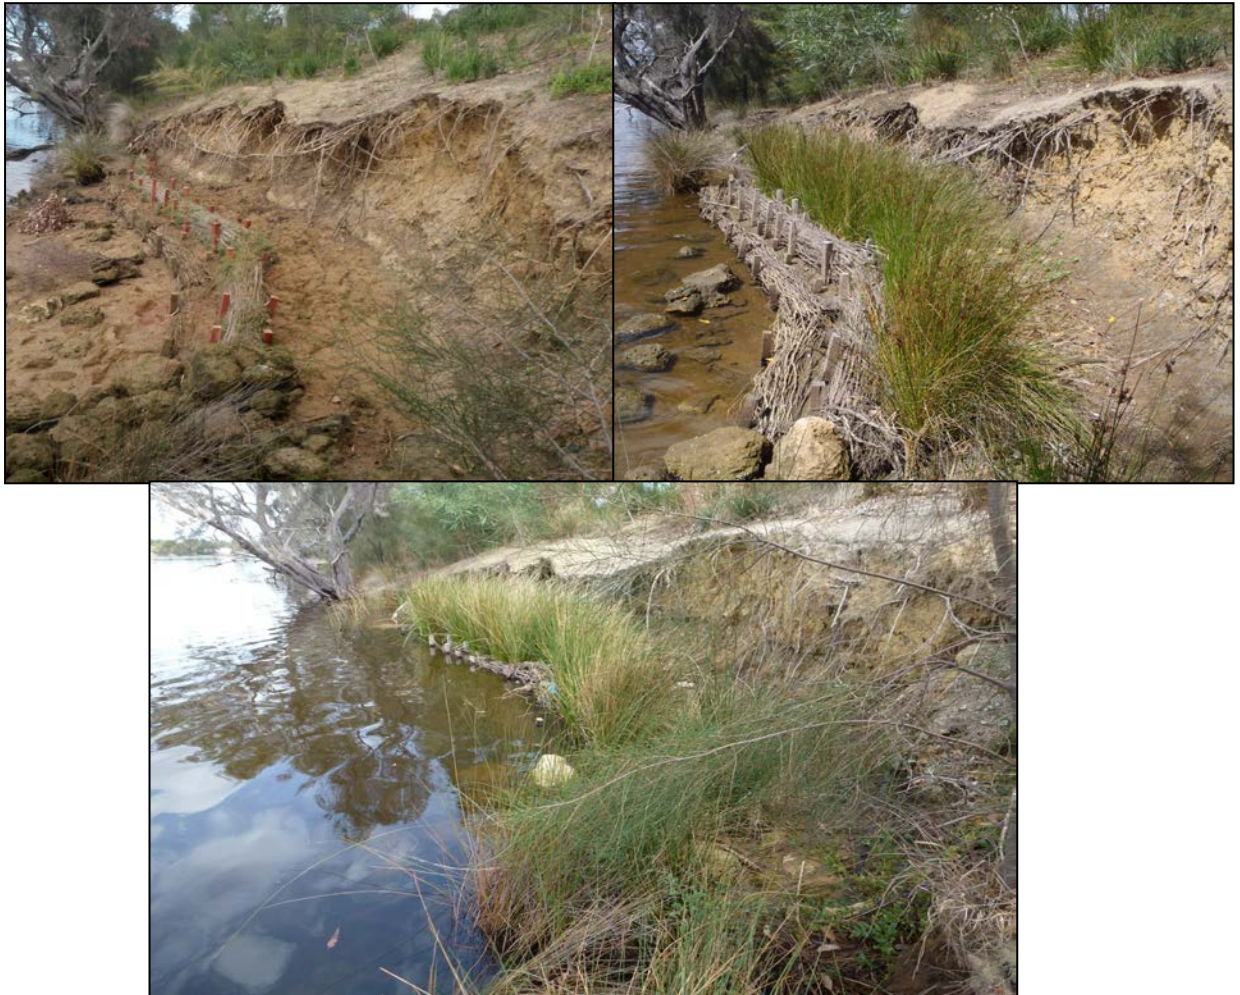
Figure 15 Brushwall examples prior to and after plant establishment and during high tide (Source: Syrinx, 2013)

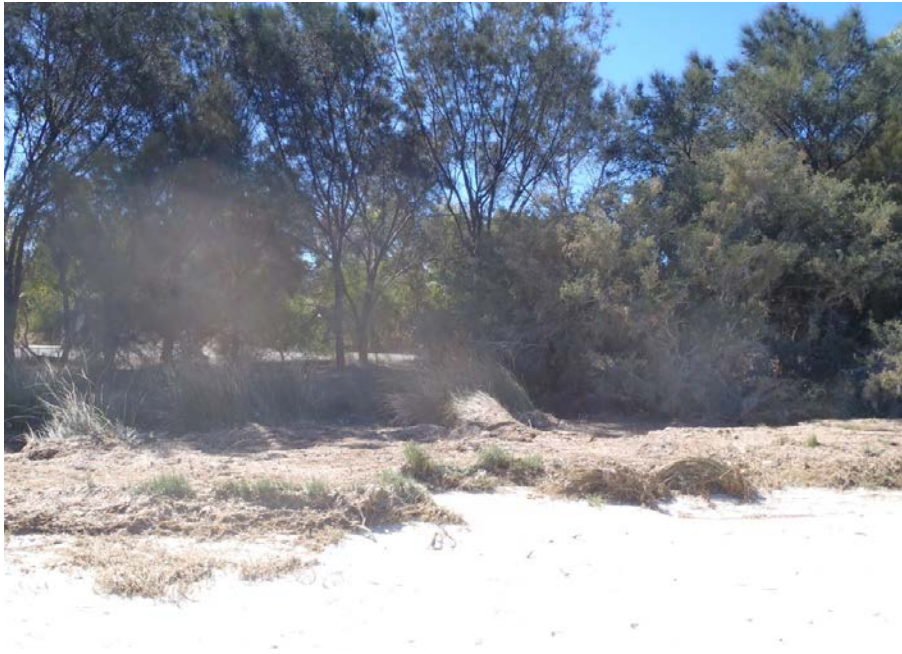
Figure 16 Foreshore treatment 2 restoration area – northern foreshore

The areas defined as Foreshore treatment 2 (Figure 16 and Figure 17) have experienced some erosion and vegetation loss; however, this is not as severe as the Foreshore treatment 1 area and therefore does not require as high restoration input or the same urgency. The particular areas along the Mount Henry Spit foreshore that have been identified as Foreshore treatment 2 have varying degrees of erosion and will require a combination of different techniques.

The northern foreshore area has experienced minor erosion; however, a distinct lack of foreshore vegetation and its close proximity to the DUP dictate its inclusion as part of Foreshore treatment 2. In addition, it would be advantageous to reduce the canopy cover of existing *Casuarina obesa* to facilitate understory vegetation (i.e. sedges) establishment through minor pruning of the canopy. These techniques have been implemented at a site directly north of the Mount Henry Spit and have been successful in aiding the establishment of the undestorey and in reducing further foreshore degradation.

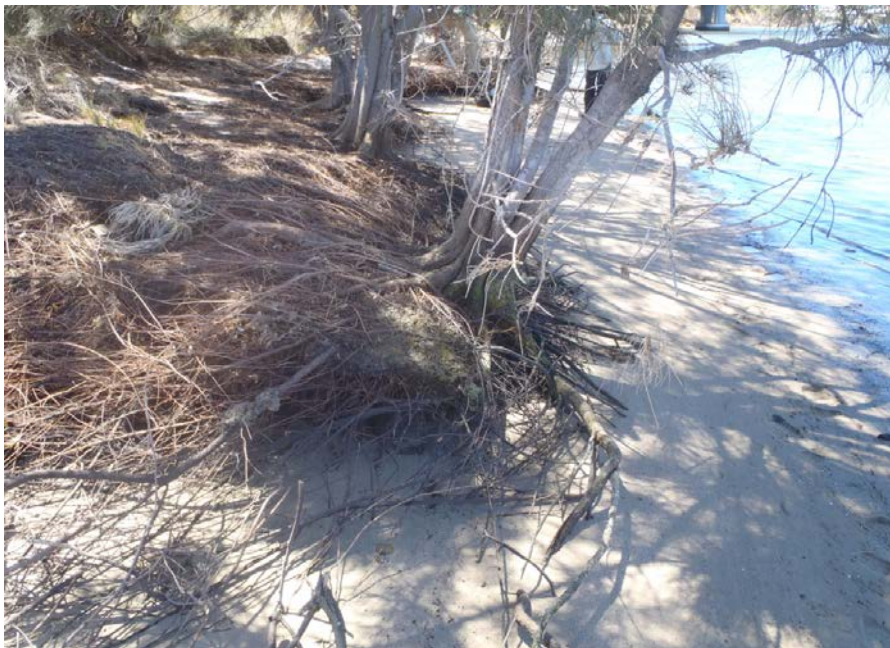
Figure 17 Foreshore treatment 2 restoration area – south western foreshore

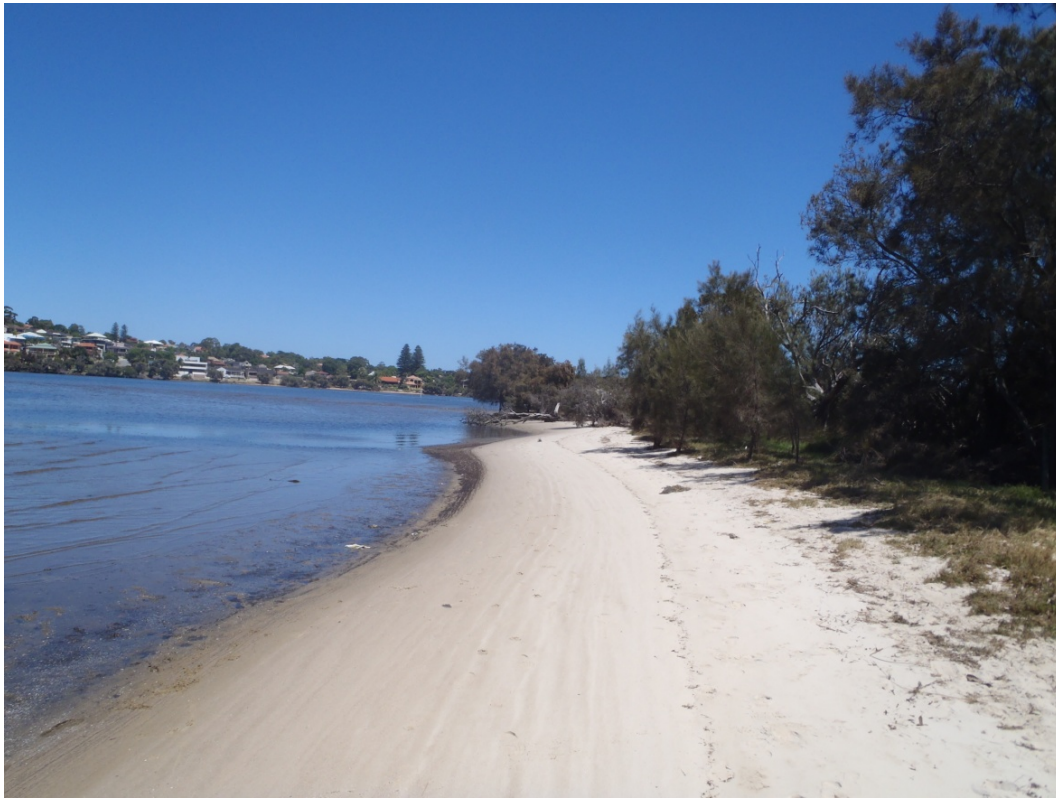
Figure 18 Foreshore treatment 3 restoration area, southern foreshore

It is recommended that these areas be monitored for signs of further erosion and degradation to ensure they do not become a higher priority and require further restoration input. This will particularly be necessary after implementing Priority 1 and 2 foreshore treatments.

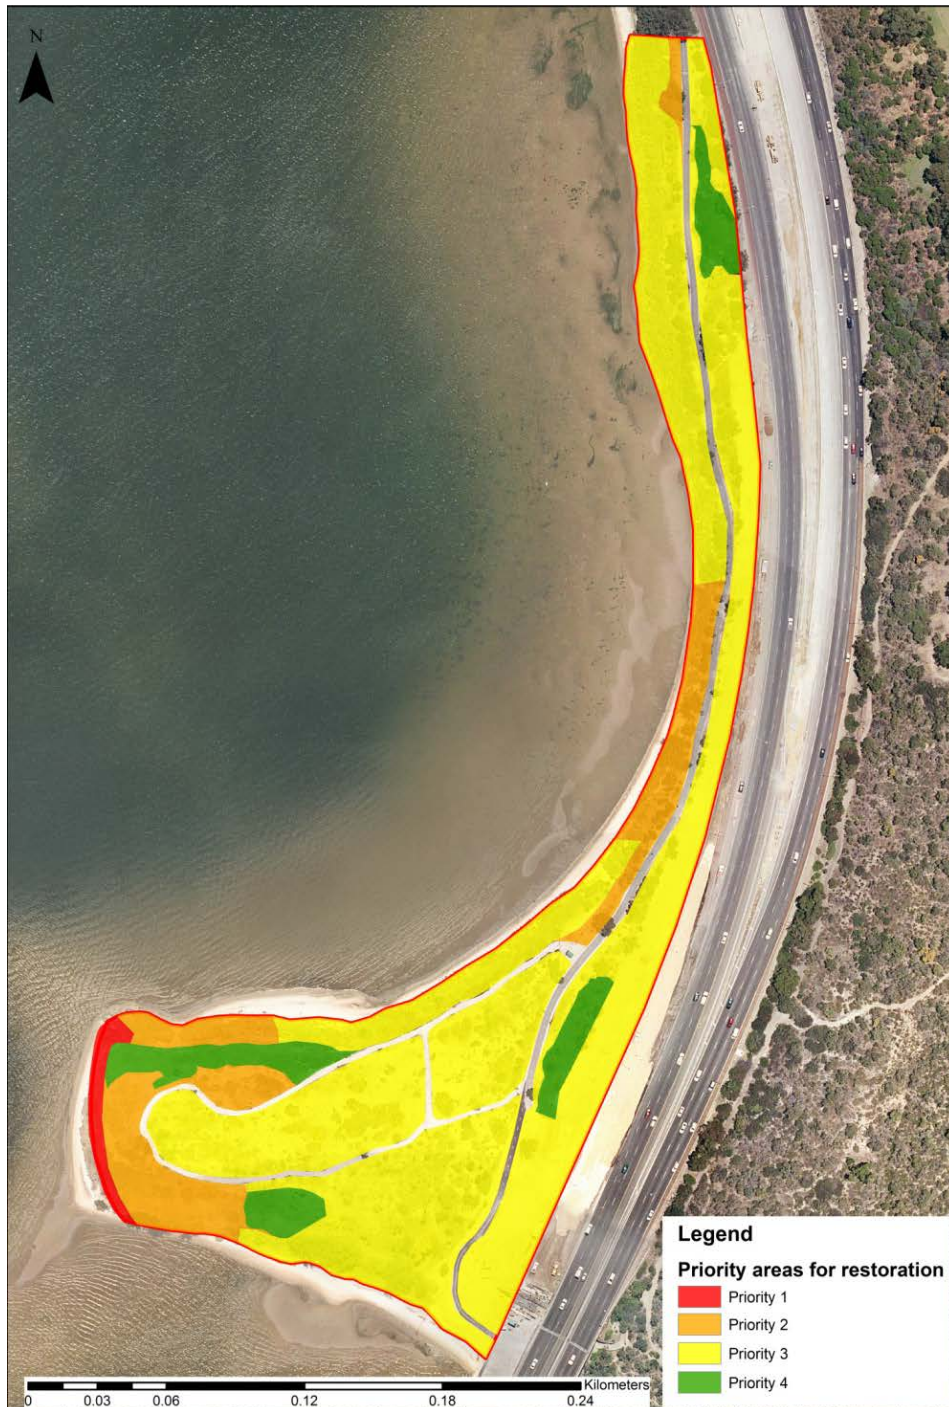
Figure 19 Priority areas for revegetation including foreshore and dryland

The same prioritisation system as applied to the erosion control works was applied to the selection of priority areas for revegetation and these are congruent with each other. The prioritisation process was based on the most impacted areas where vegetation cover is low (or non – existent), areas of high erosion and where such cover would improve ecosystem function in such a way that it would ensure long term survival of vegetation communities on the Mount Henry Spit. The priority areas for both foreshore and dryland are outlined in Figure 19. Whilst the highest need for restoration works is within the Priority 1 area, other areas may be addressed at the same time (with consideration of available funds/ budget). Priority 4 areas do not need additional planting as they have dense strands of healthy native flora. However, they require monitoring and maintenance particularly weed control, in order to be sustainable in the long term.
