TECHNICAL REPORT

MOUNT HENRY SPIT RESTORATION PLAN

SEPTEMBER 2014

FOR
CITY OF SOUTH PERTH

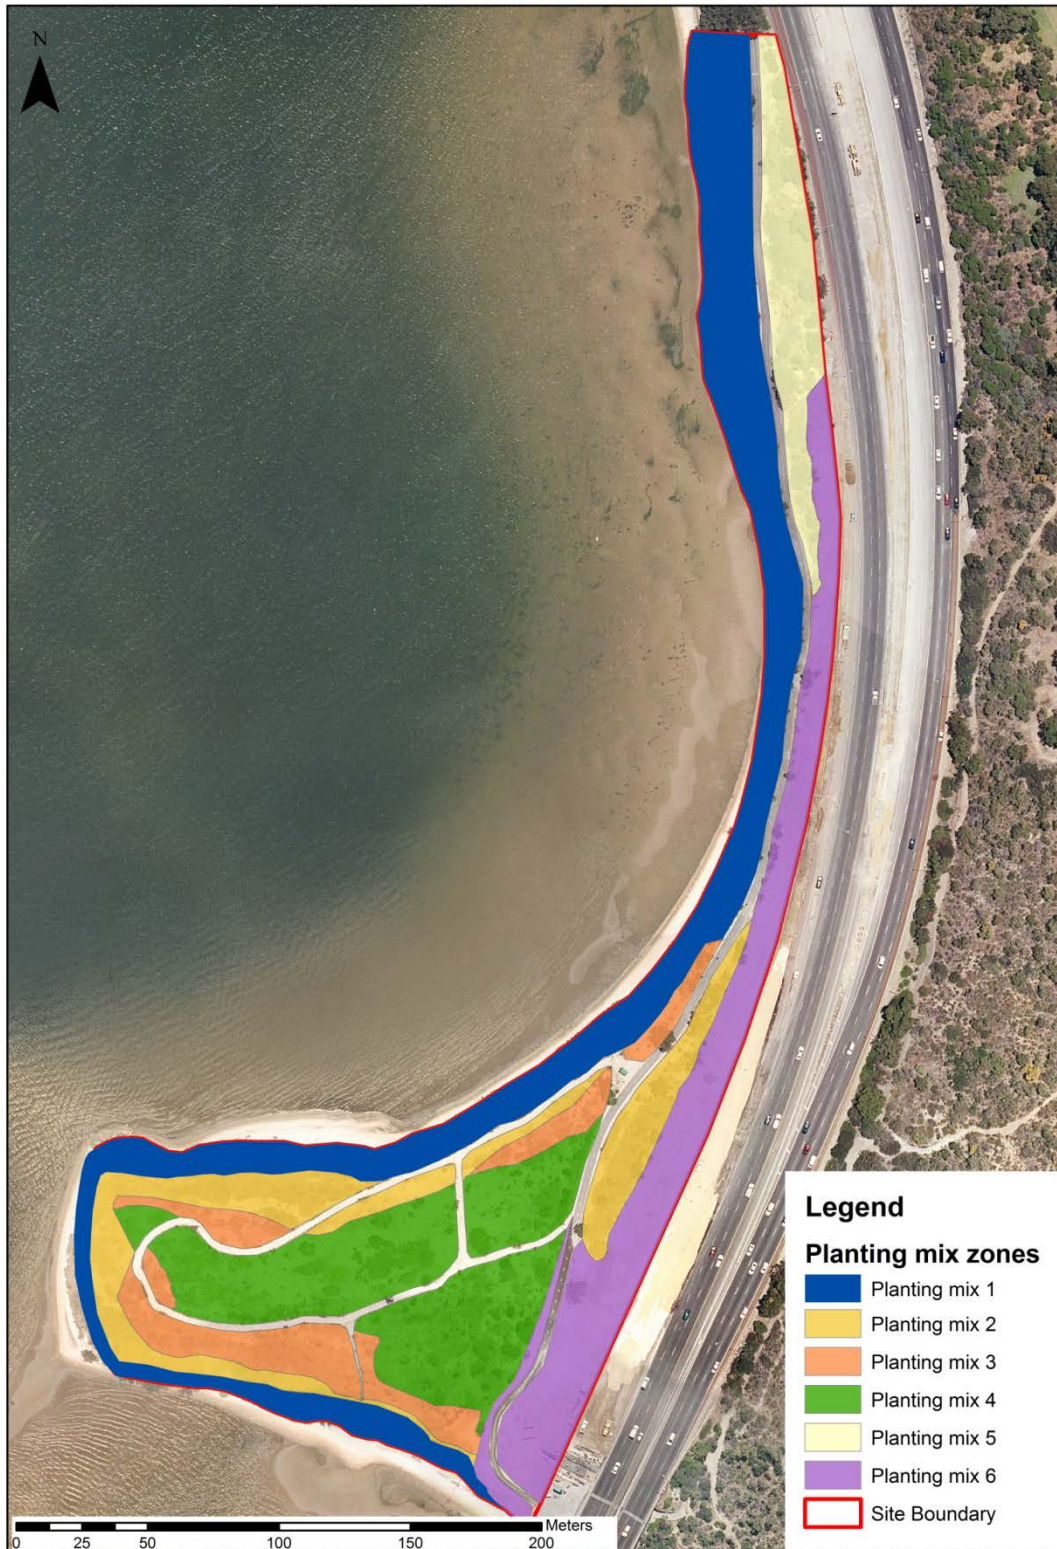
Figure 20 Planting zones congruent with the existing vegetation communities on site

The species selection for revegetation was based on the existing indigenous flora and vegetation on site. Careful delineation in vegetation communities was made with respect to topography and the surface water flows across the Site, with the aim to replicate the historical condition and vegetation communities on site. The figure showing the proposed extent of each vegetation community boundary is presented in Figure 20. These boundaries

may change due to climate change impacts; however, in the short term (e.g. next 5-10 years) they are considered accurate. The corresponding planting species selection for each community is presented in Table 3 the selection incorporates species that were recorded on site previously by Ecoscape (2004).

As can be noted from Figure 20, Planting Mix 6 is specified for the area of the freeway embankment which currently has relatively high vegetation cover. However, this cover is predominantly composed of introduced flora or native species that are relatively weedy such as *Acacia saligna*. The proposed planting mix focuses on re-introduction of some native indigenous flora to this section of the Site such as the low shrubs herbs and sedges in particular. The planned numbers for revegetation of this area are low due to the already high vegetation cover in the area.

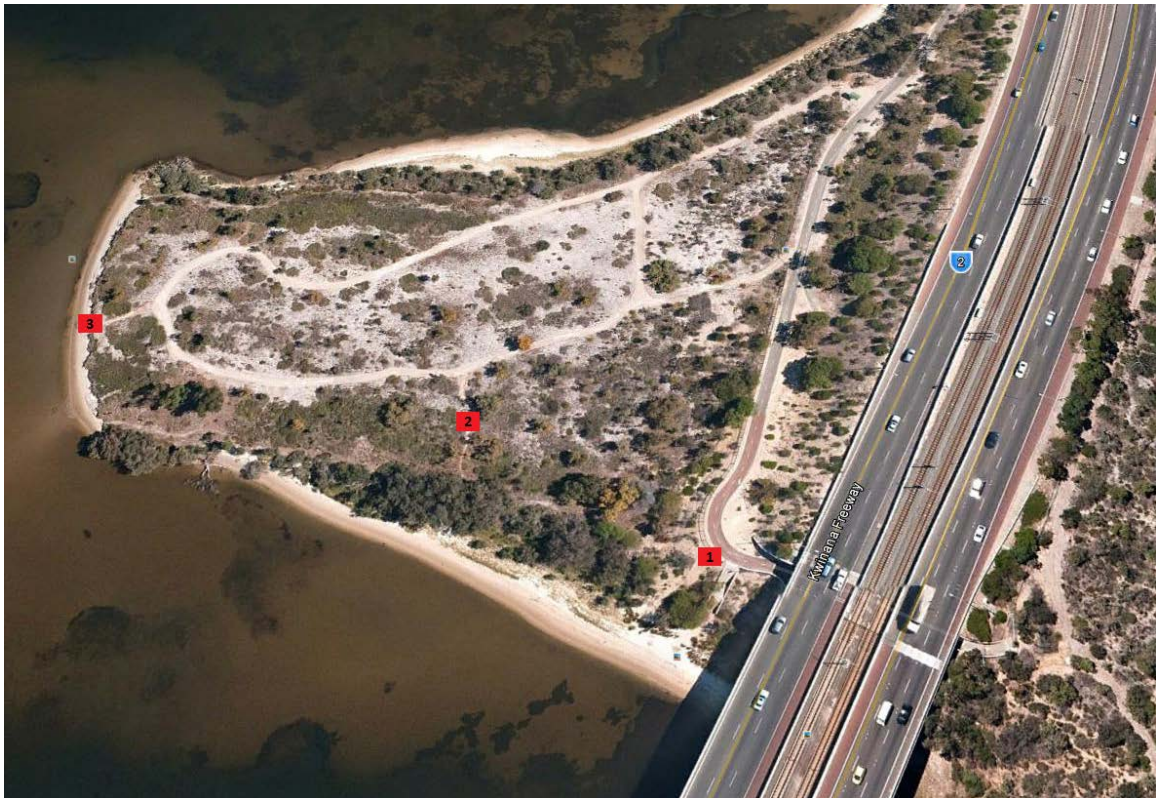
Figure 21 Proposed access management areas

It is understood that closing many of these tracks will encourage the creation of new tracks, contributing to further degradation. The best approach therefore will be to restrict access to a few key areas and to formalise access in others. There are three specific areas where initial efforts should be made to regulate access on site as indicated in Figure 21.

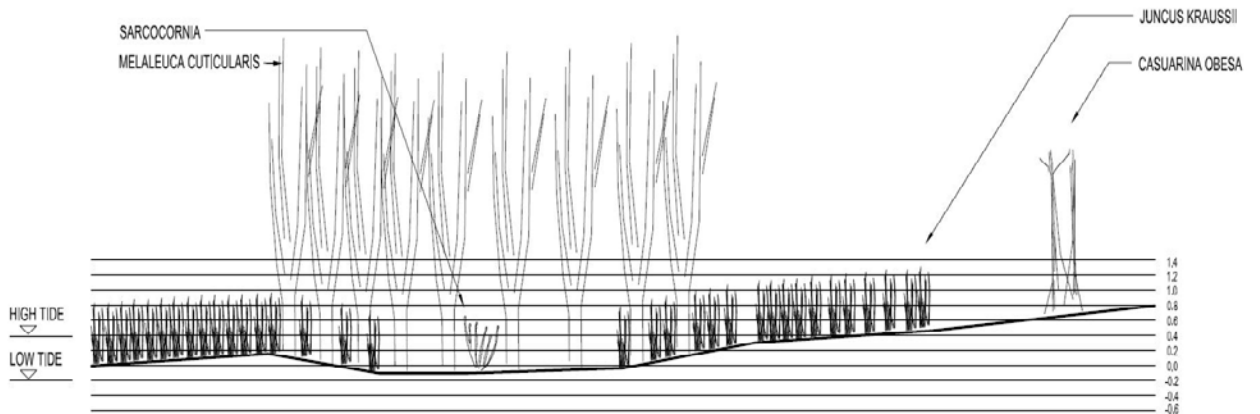
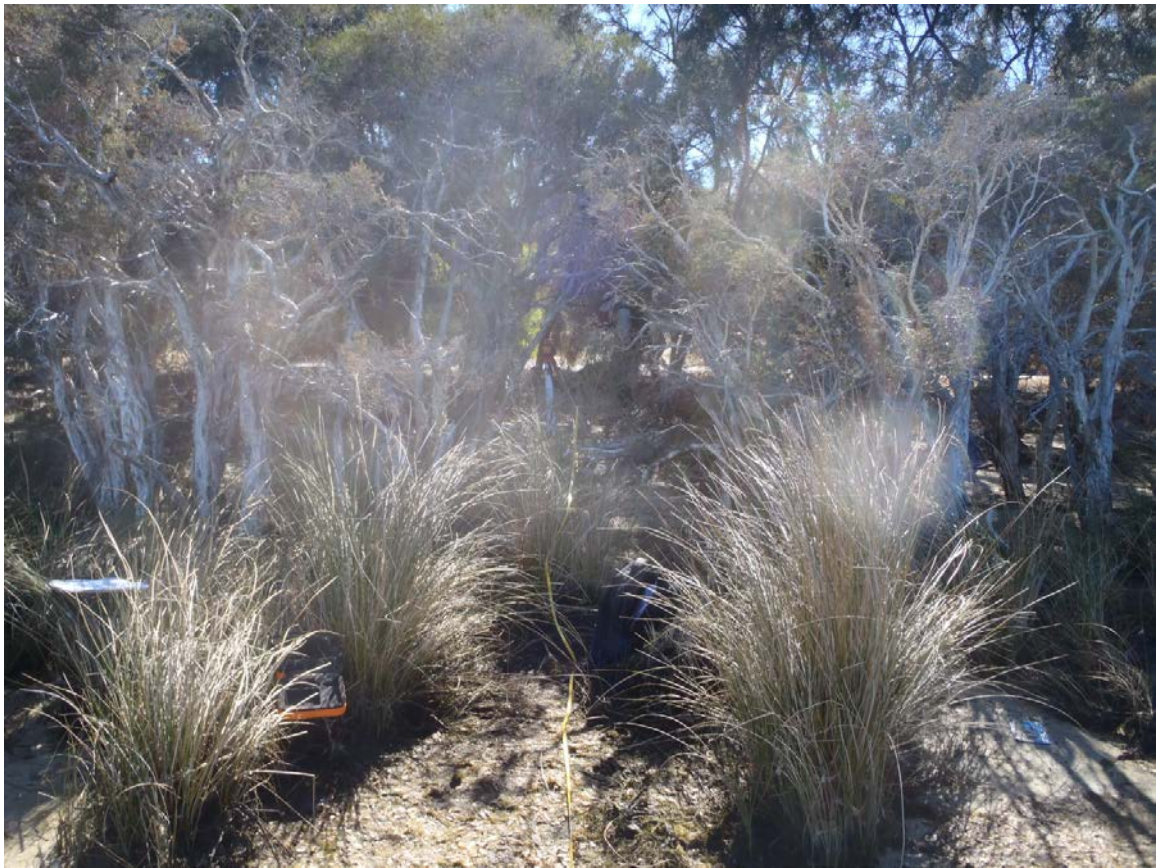
SECTION 1

Figure 2. Section 1 foreshore profile

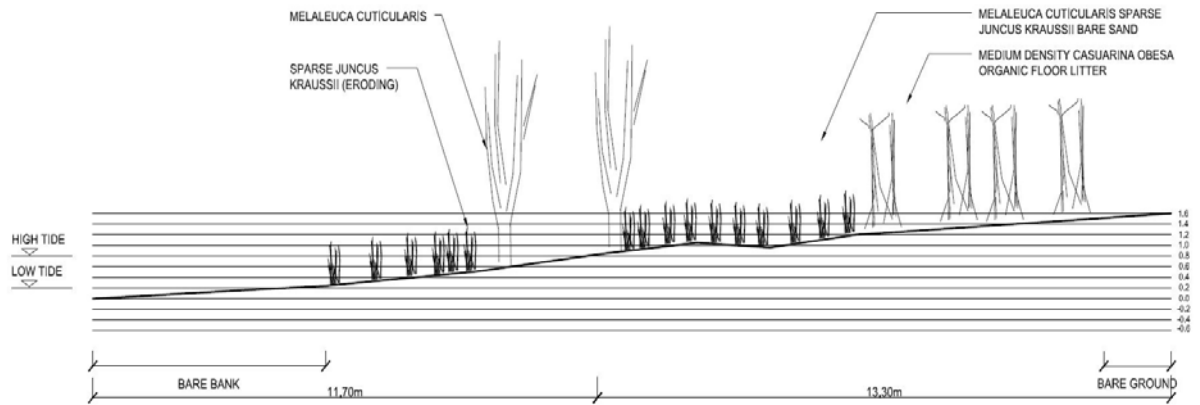
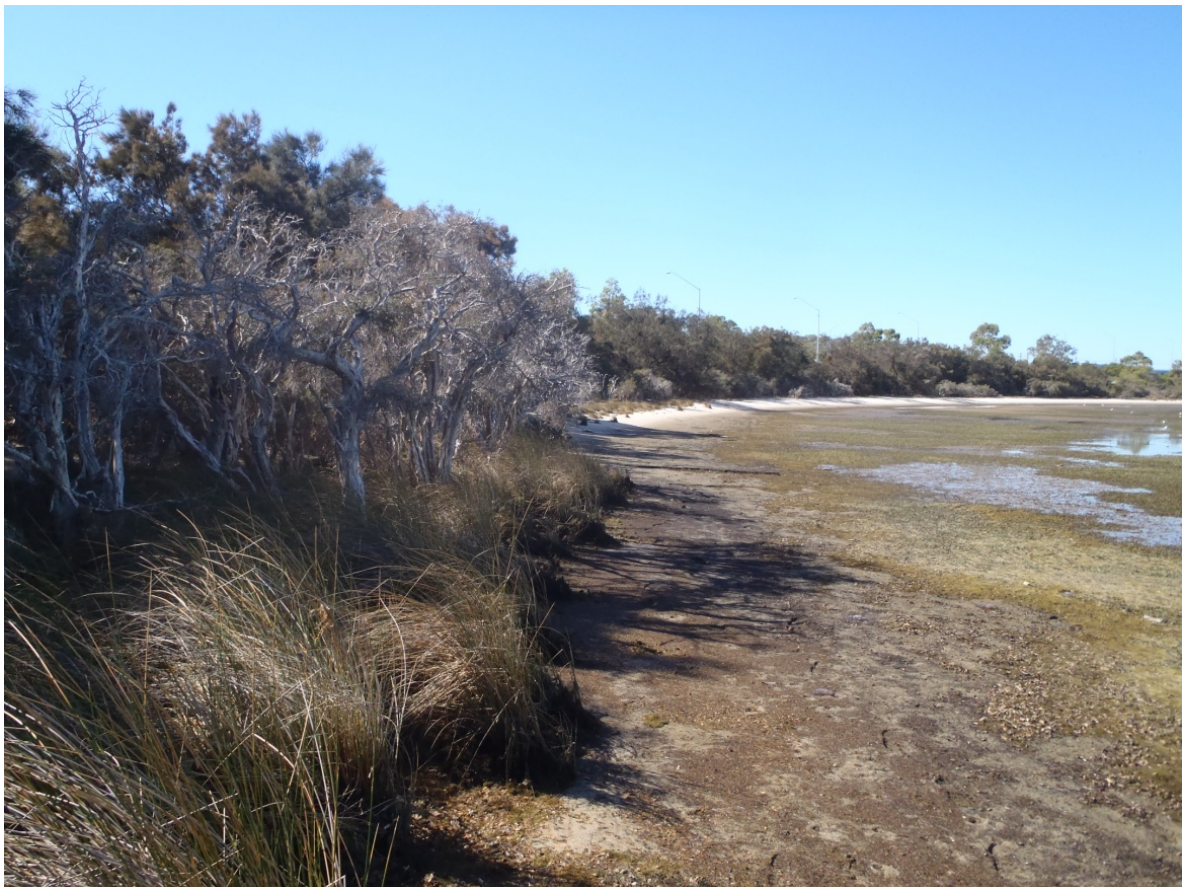
SECTION 2

Figure 3. Section 2 foreshore profile

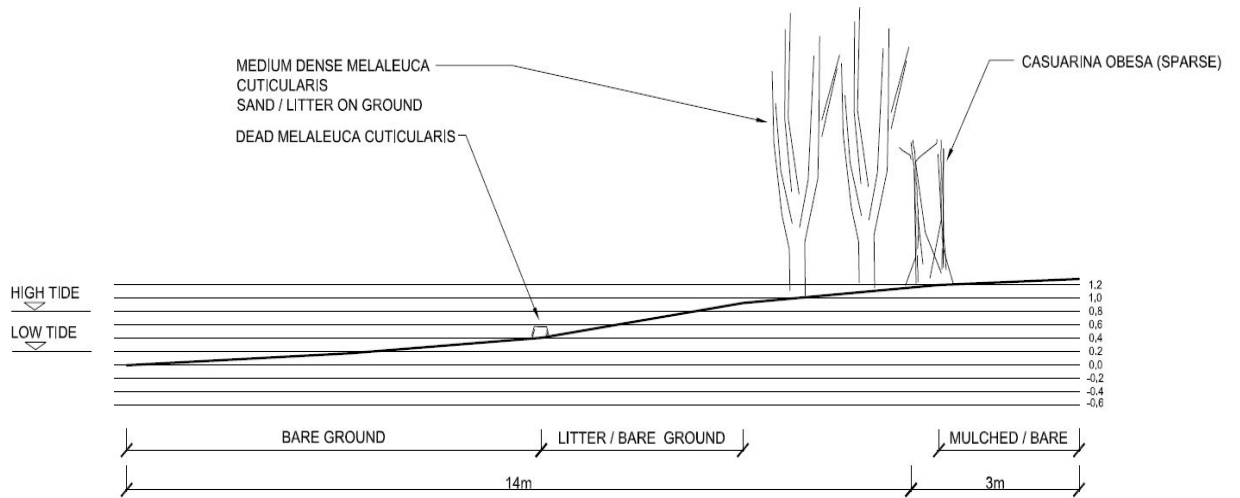
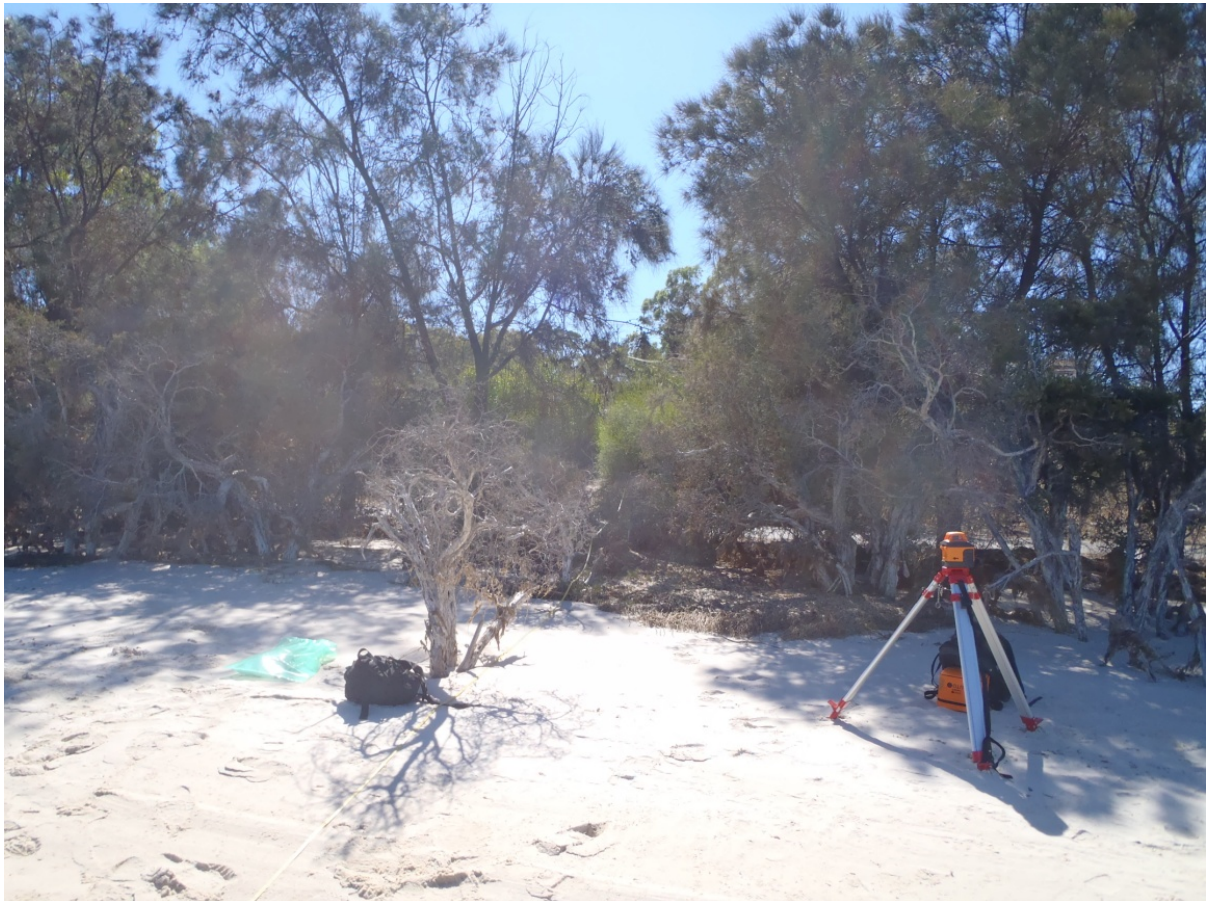
SECTION 3

Figure 4. Section 3 foreshore profile

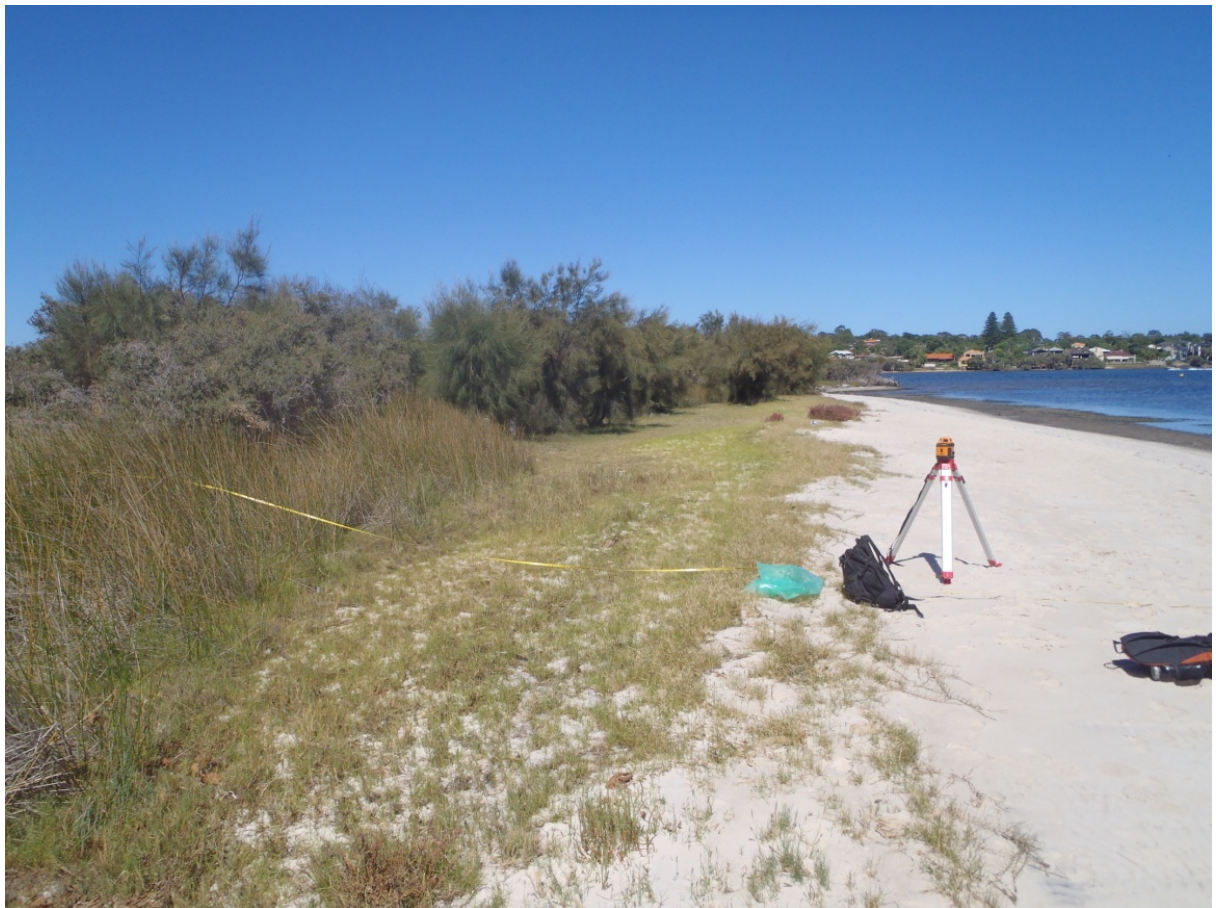
SECTION 4

Figure 5. Section 4 foreshore profile

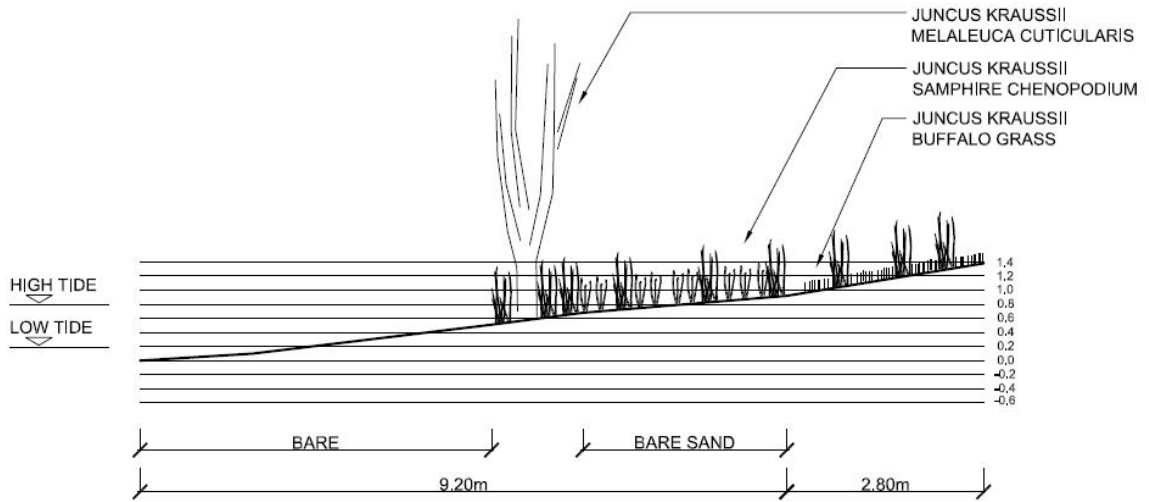
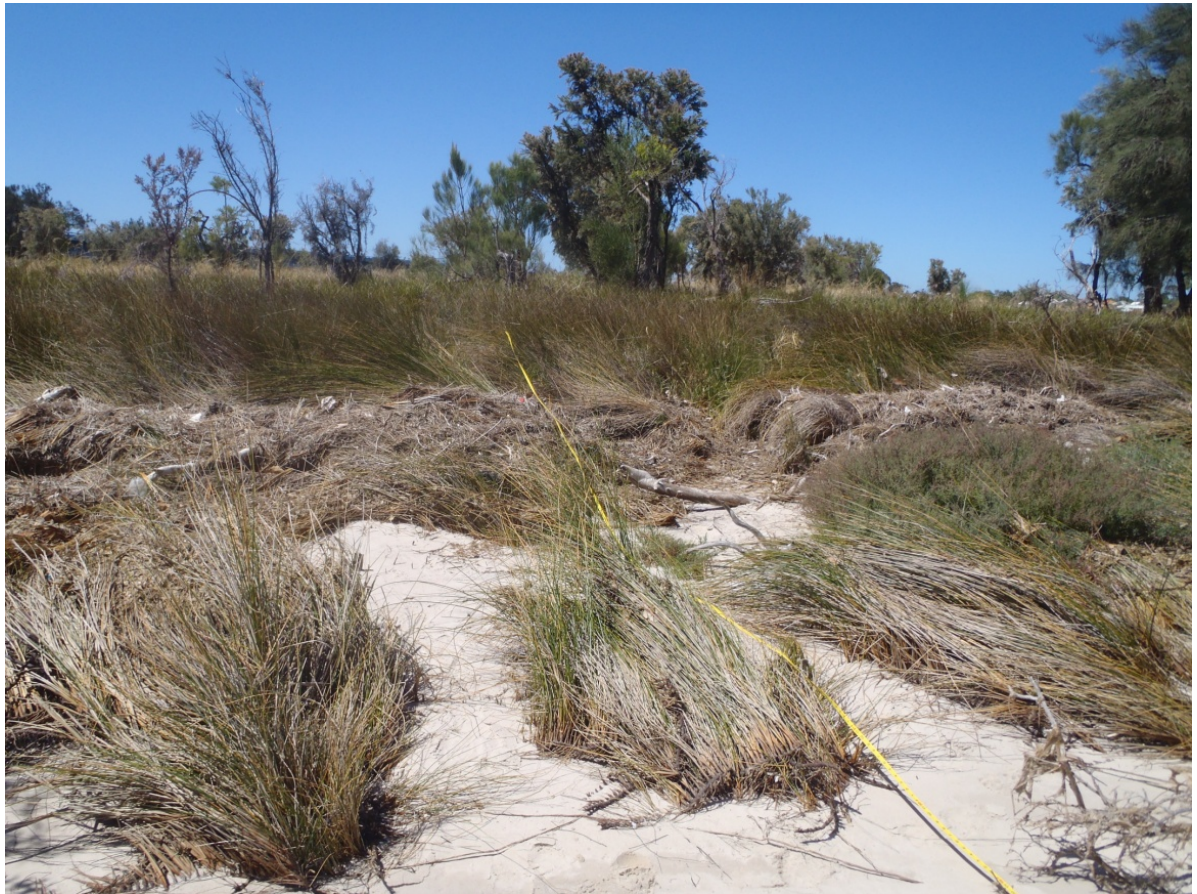
SECTION 5

Figure 6. Section 5 foreshore profile

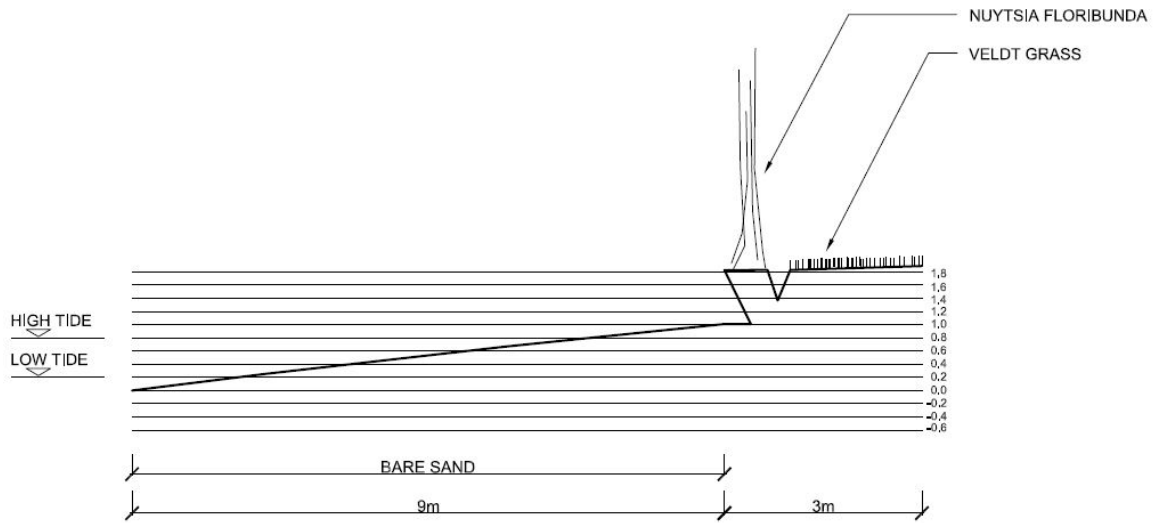
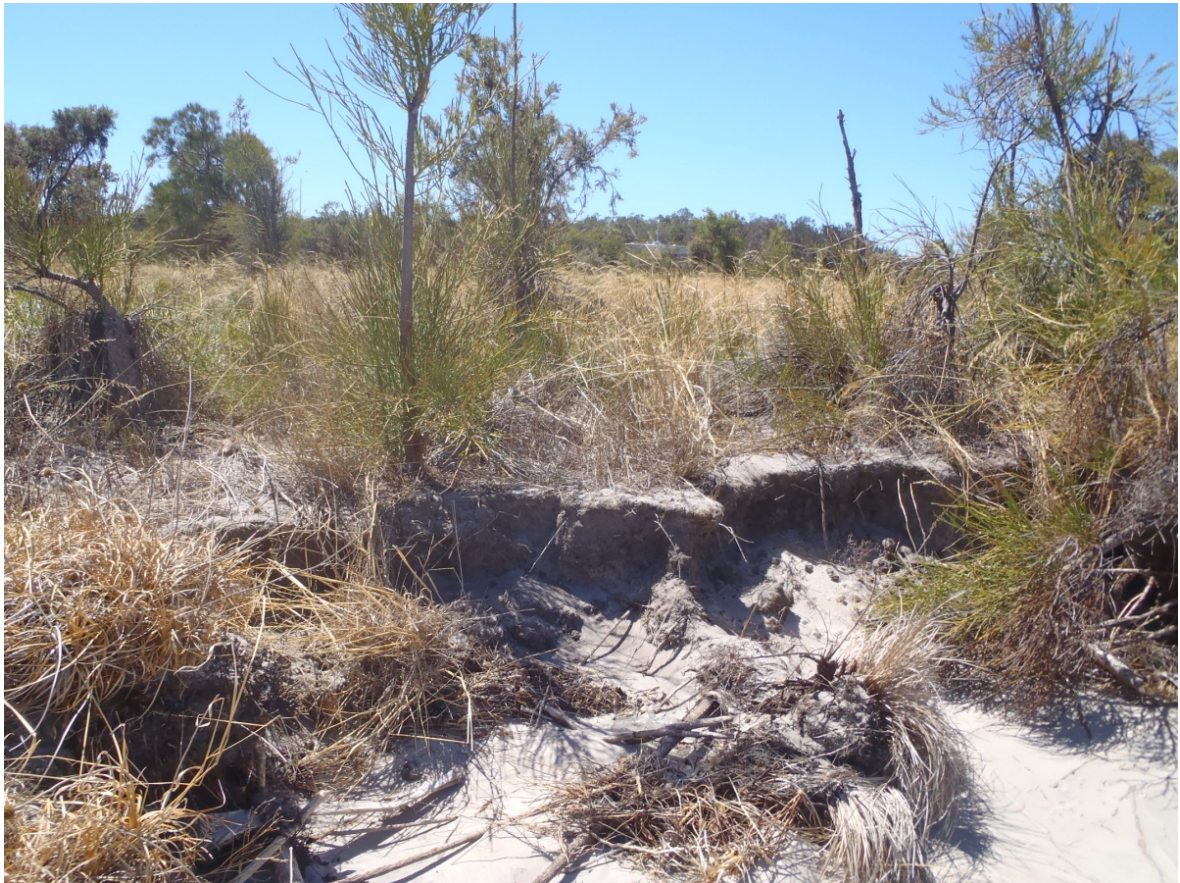
SECTION 6

Figure 7. Section 6 foreshore profile

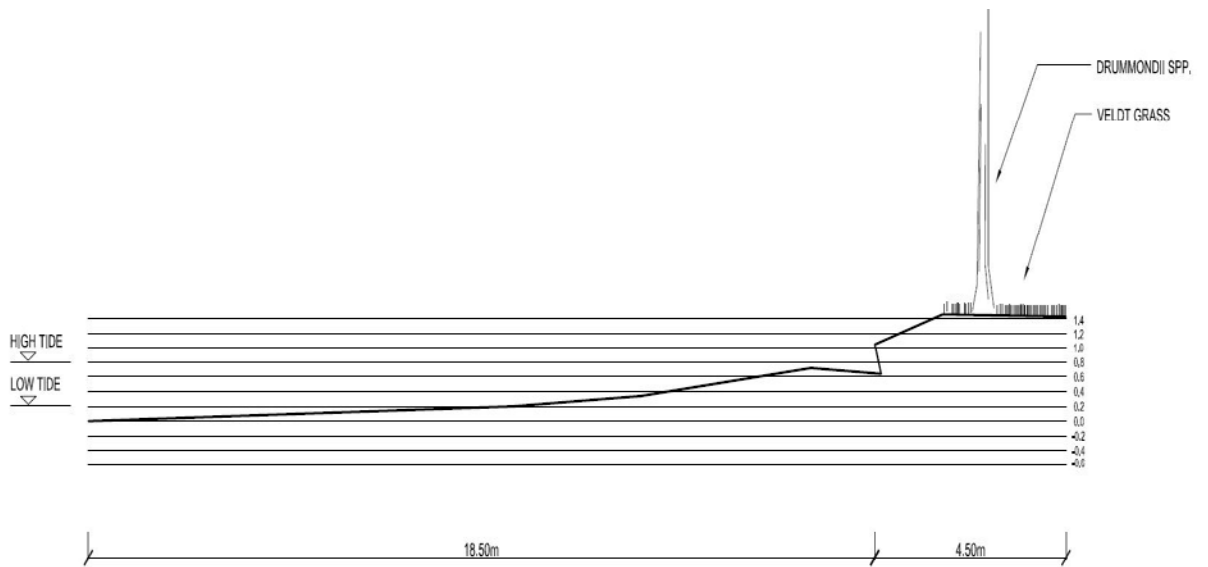
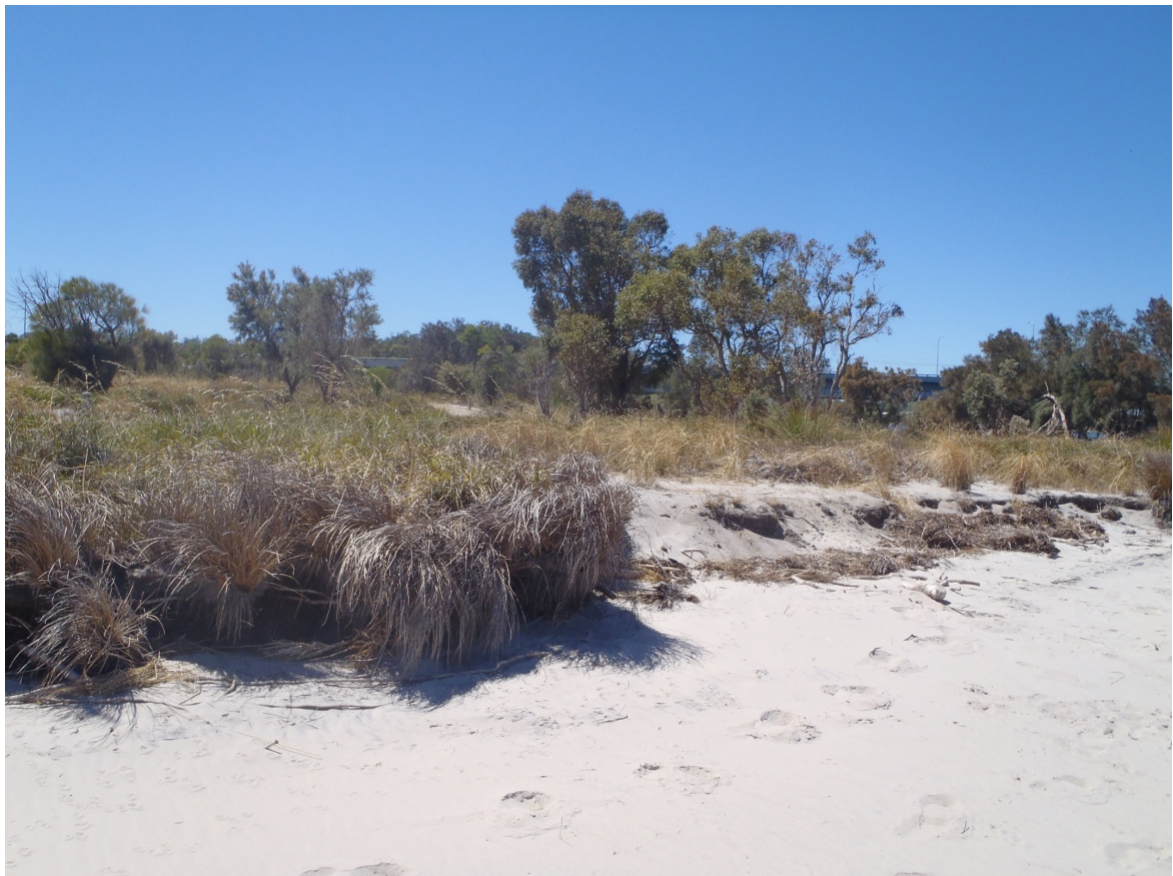
SECTION 7

Figure 8. Section 7 foreshore profile

Section 7 (Figure 8) shows a high level of erosion with undercutting clearly visible and a large sand spit exposed during low tide. Multiple informal paths and dense vegetation are present on the upper embankment.

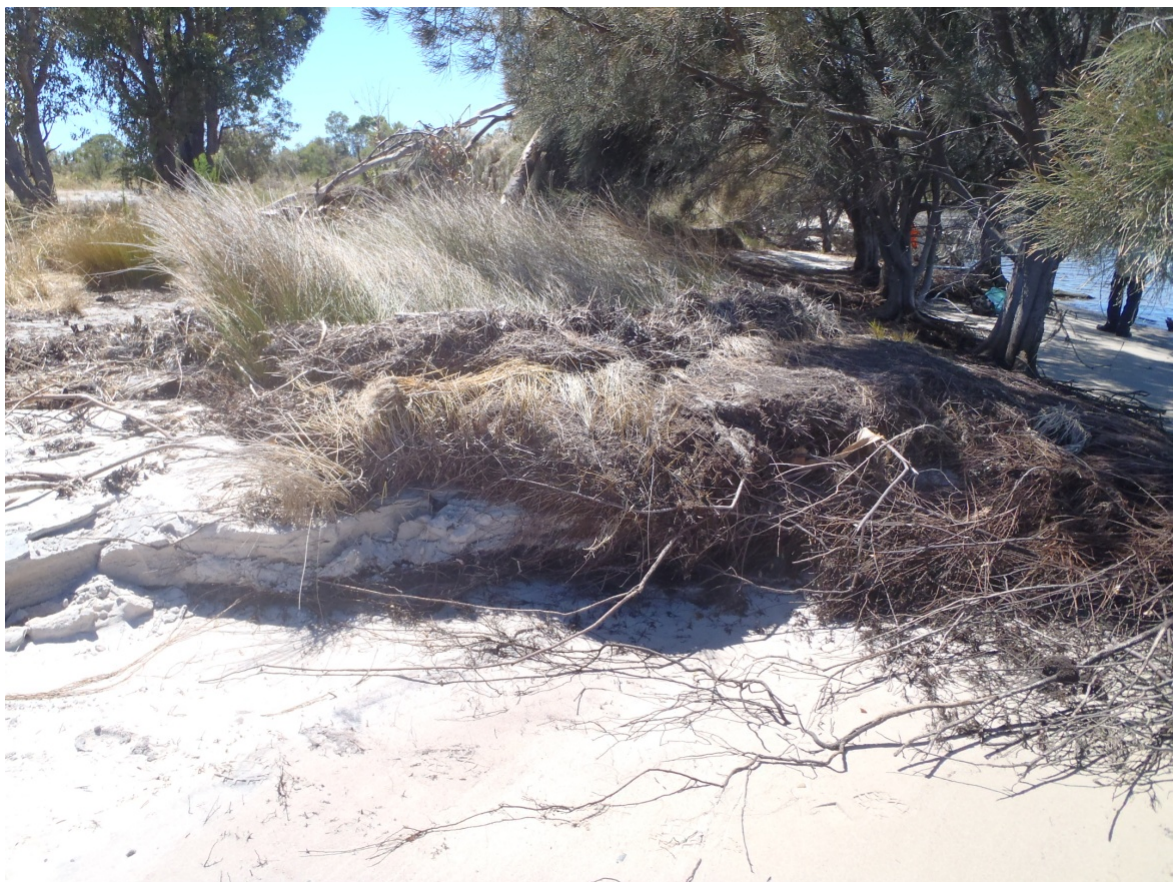
SECTION 8

Figure 9. Section 8 foreshore profile

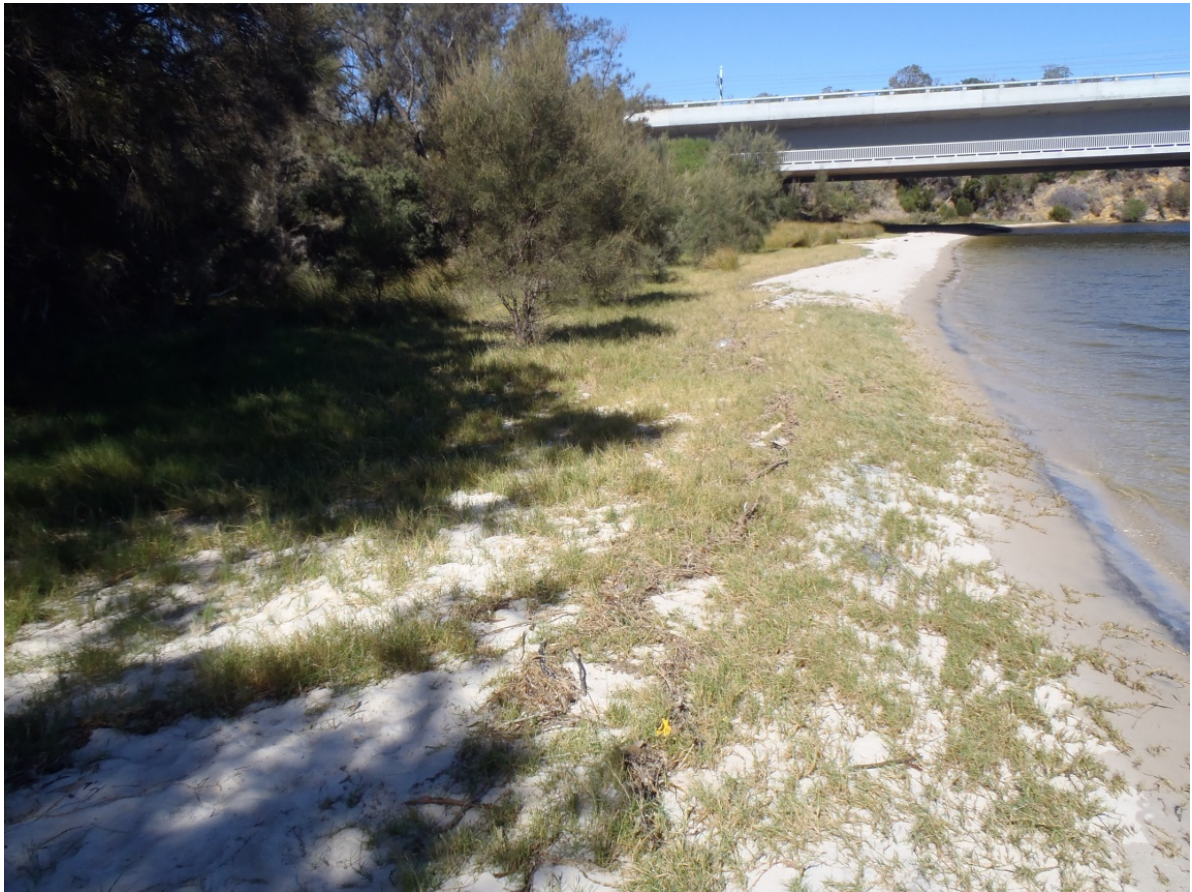
SECTION 9

Figure 10. Section 9 foreshore profile

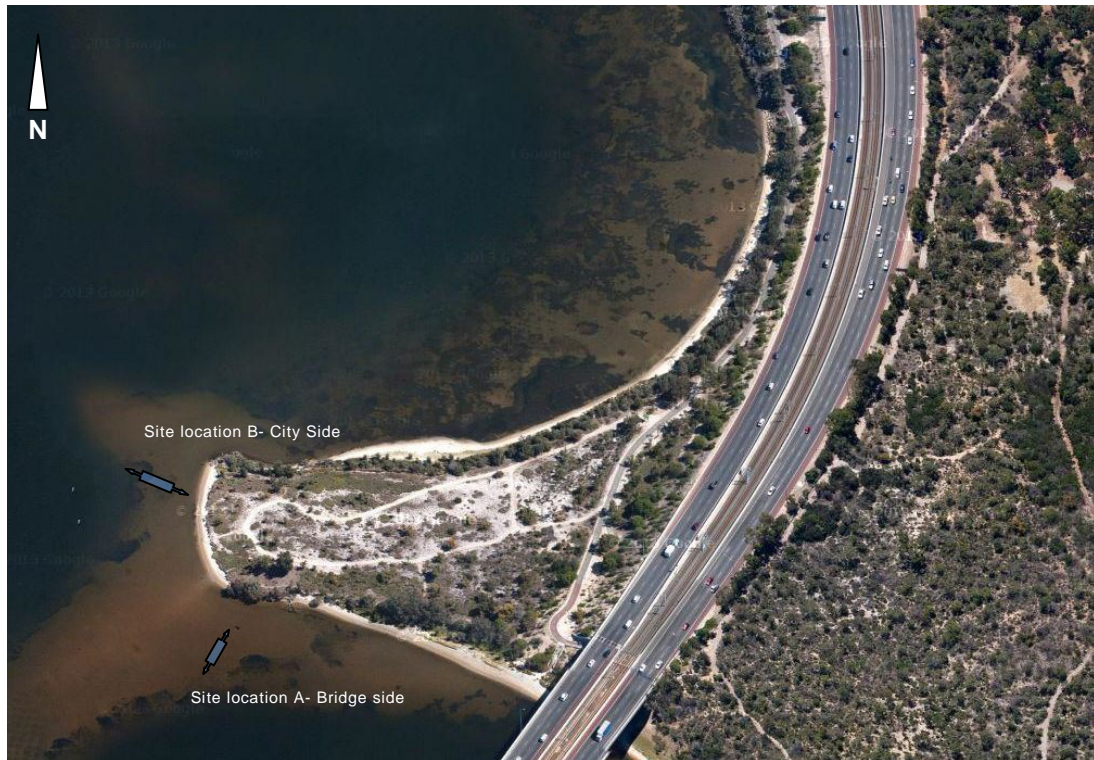
Figure 1 Location of Starflow Ultrasonic Doppler flow meters used to estimate the wave velocity at Mount Henry Spit

wave impact was measured at the likely point of maximum velocity. This point was inferred from aerial photograph observations of the landmass loss at the westernmost end of the Spit from 1953 to 2013 and in the field observations of onshore waves.

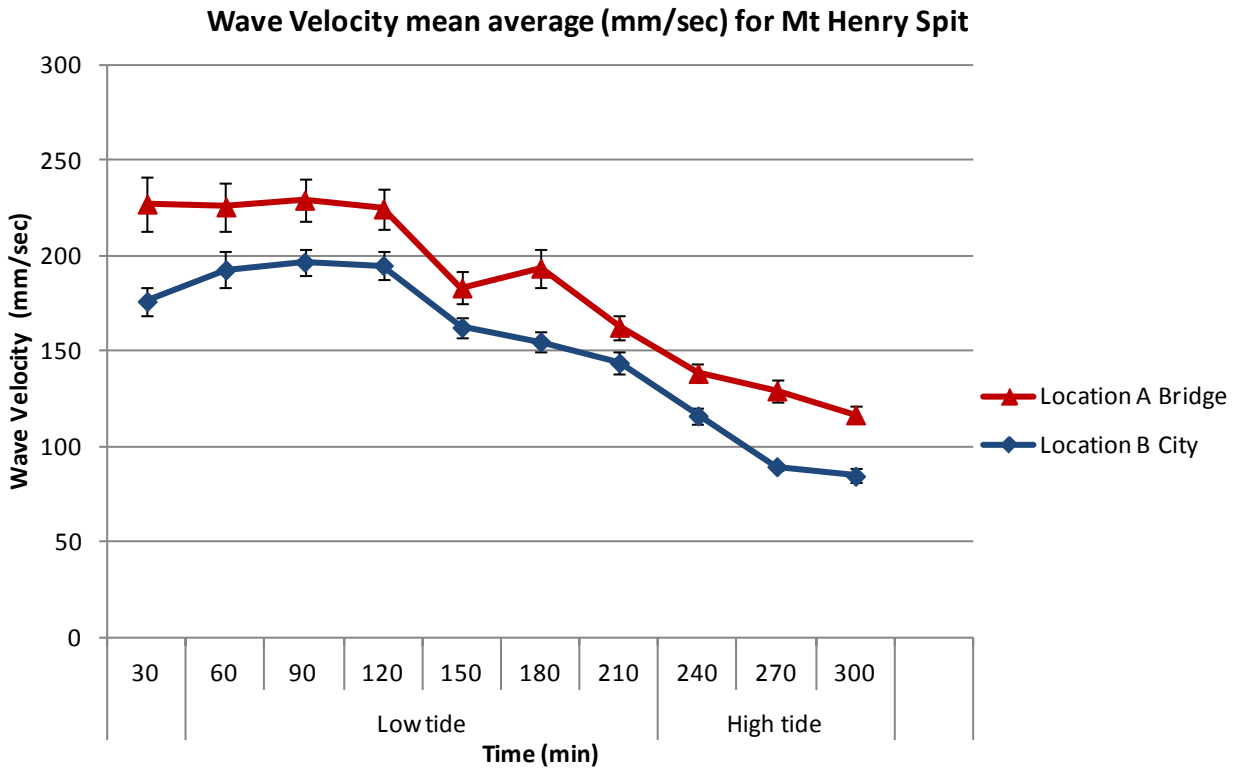
Figure 2 Line Graph of wave velocity data for locations A (Bridge side) and B (City side)

The wave velocity measurements at Location A (southerly facing foreshore) and Location B (westerly facing foreshore) show higher mean average wave velocities at Location A, which is consistent with the observations on the day (see Table 2). The prevailing wind direction at Location A was from the south to south west which forced waves into the wash zone at high speeds averaging between 190 -240 mm/sec at low tide and 120 -190 mm/sec at high tide. This indicates that at low tides, wave velocity will be greater and thus create a greater impact on the wash zone of foreshore at this location. This scenario is most noticeable in the resultant undercutting occurring of the bank along the foreshore currently compromising indigenous flora of *Melaleuca cuticularis* and *Casuarina obesa*.

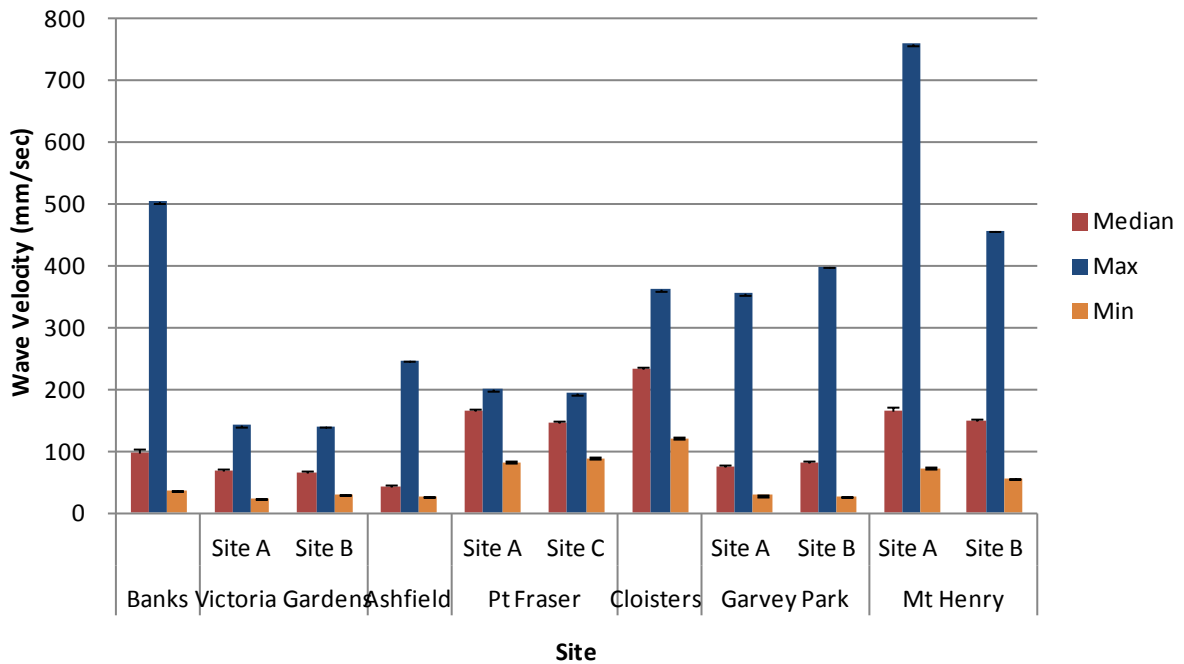
Swan and Canning Rivers Wave Velocity Comparisons

Figure 3 Comparisons of wave velocity at various locations within the Swan and Canning Rivers (Source: Syrinx Environmental PL)
